# **Little River Corridor Plan**

**Stowe, Waterbury, Morristown, Worcester,  
Bolton, Underhill and Cambridge, Vermont**  
**Draft April 21, 2010**

Bear Creek Environmental, LLC  
297 East Bear Swamp Road  
Middlesex, Vermont 05602

The Lamoille County Planning Commission  
632 LaPorte Road  
Morrisville, VT 05661

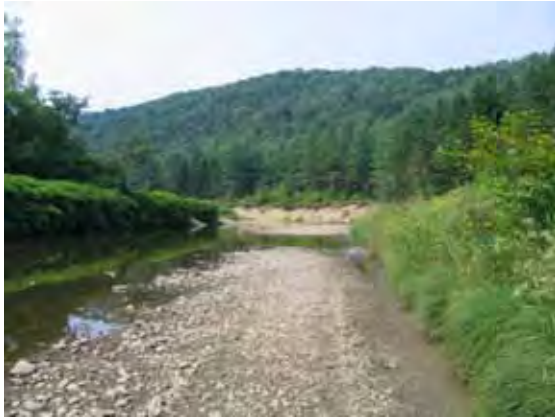
**Figure 7.1. Large side bar and mass failure in Segment M06-B**

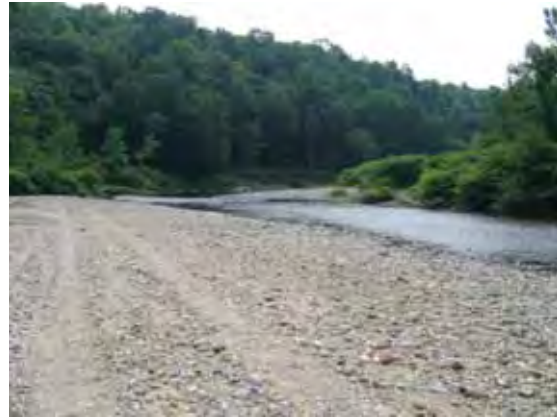
**Figure 7.2. Another large side bar in Segment M06-B**

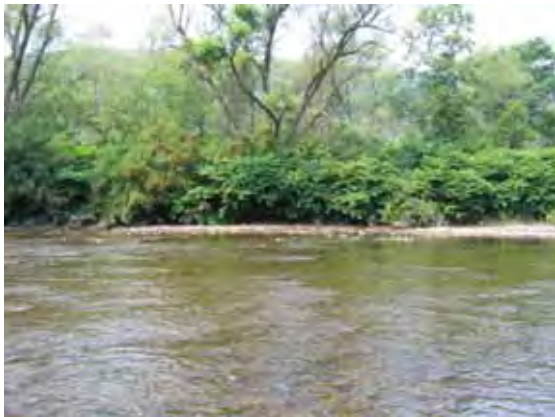
Segment M06-B is a "C" gravel dominated segment. The rapid geomorphic assessment (RGA) scored in the "fair" category due to the major historic degradation, major widening and aggradation, and minor planform adjustment. The reference channel width is 92 feet, but the bankfull width in the cross section was measured as 133 feet (Figure 7.3) indicating that the segment is over widened. The large depositional features are a result of the over widened channel. The rapid habitat assessment (RHA) rated in the "fair" category mostly due to deposition in the channel, channel straightening, and bank erosion.

**Figure 7.3. Typical wide cross section in M06-B**

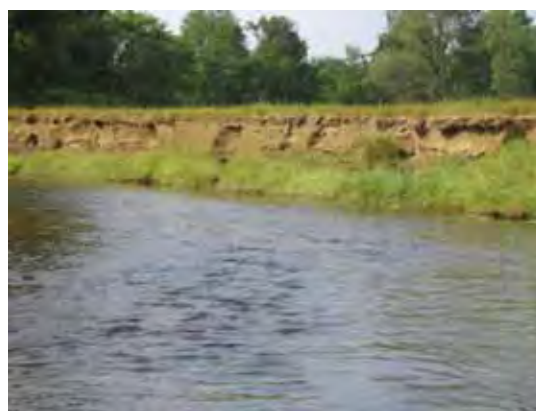
**Figure 7.5. Reach M07 has a significant lack of buffer causing bank failure.**

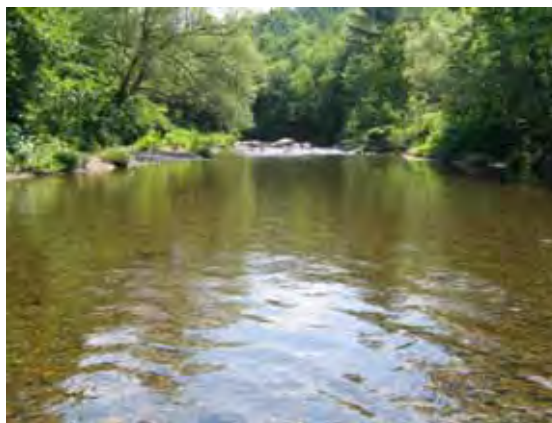
Reach M08 has experienced a stream type departure from a gravel dominated "C" stream to an "F" stream type due to the extreme historic incision. RGA rated in the "fair" category due to major widening and minor aggradation and planform adjustment. There are three steep riffles, some mid-channel bars and many side bars in M08 indicating that it is depositional. Pools have been filled in with sediment with the bed profile dominated by runs (Figure 7.6). The RHA also scored in the "fair" category as a result of extensive channel straightening, embedded bed substrate, unstable banks, and reduced riparian buffer. This reach would benefit from buffer restoration.

**Figure 7.6. Long run in Reach M08**

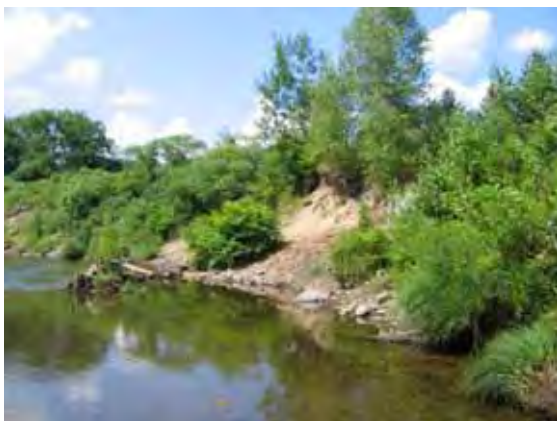
**Figure 7.7. Bank erosion along M09**

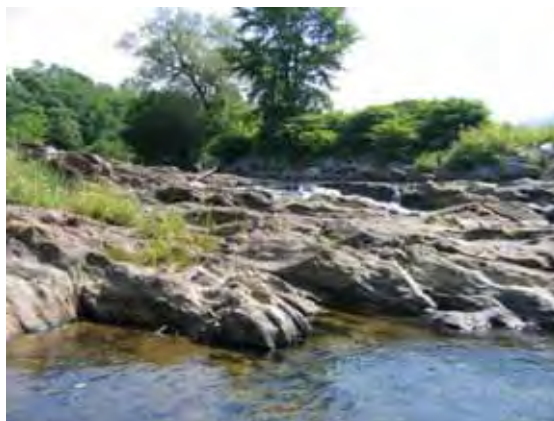
Reach M10 begins on the downstream end where there are bedrock grade controls (Figure 7.9) and commercial development within the corridor. The reach is 1,180 feet in length. The valley confinement is broad and there is no human-caused change in valley confinement. The corridor of reach M10 has considerable development along it with 60 percent of the north side developed and approximately 40 percent development on the south side. Straightening has occurred along approximately  $\frac{3}{4}$  of the reach and the reach has been armored for about half its length with rip-rap along both banks.

**Figure 7.9. Bedrock grade control in Reach M10**

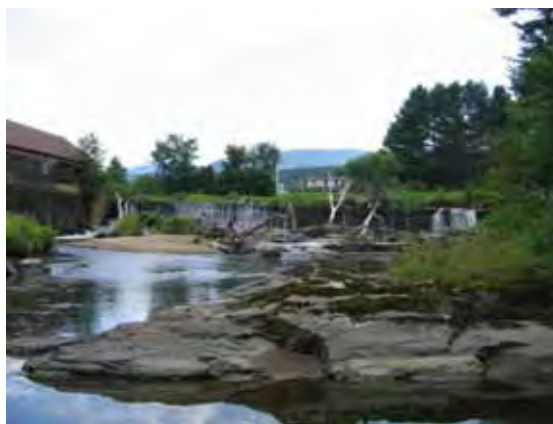
**Figure 7.10. Dam at upstream end of M10**

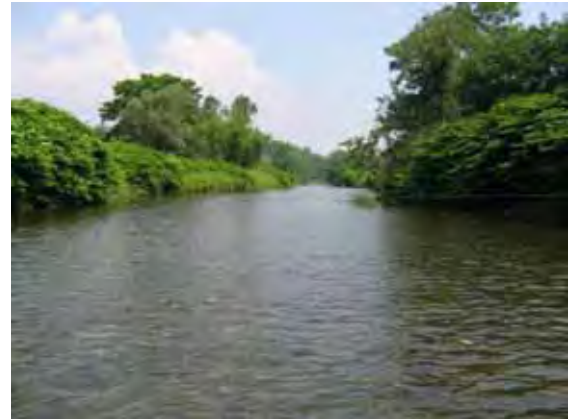
**Figure 7.12 Lack of bedform features in Segment M12-A**

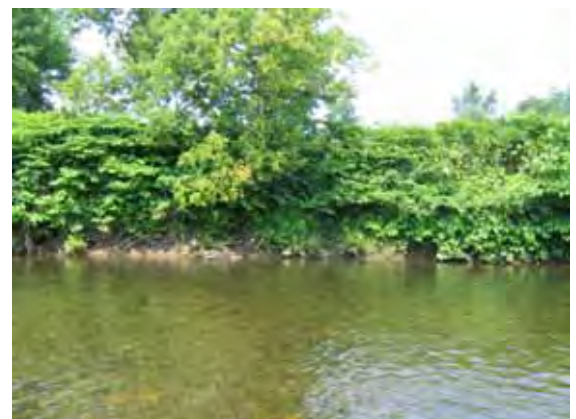
**Figure 7.13. Invasive vegetation on the banks of Segment M12-A**

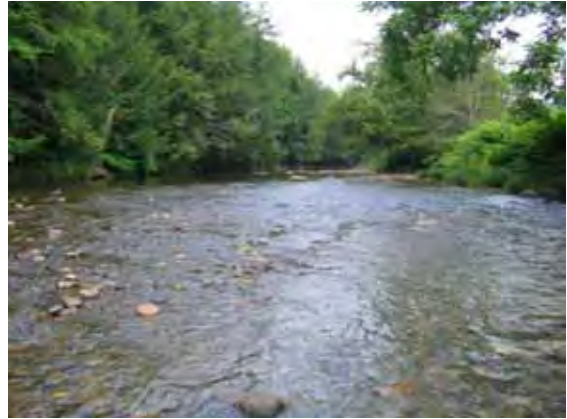
**Figure 7.14. Typical straightened channel in M12-B**

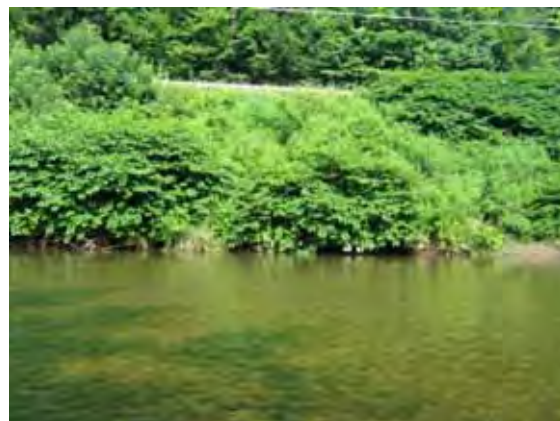
**Figure 7.15. Elevated River Road along Reach M13**

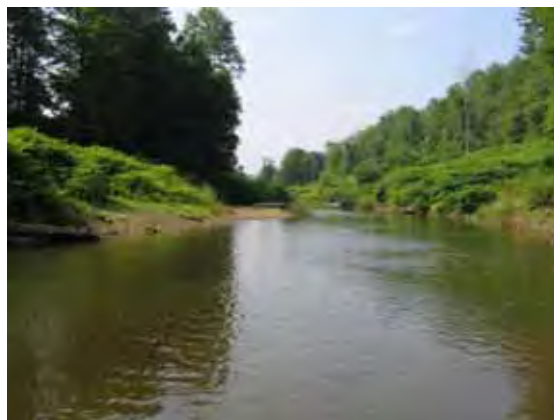
**Figure 7.16. Invasive vegetation within both buffers in M13**

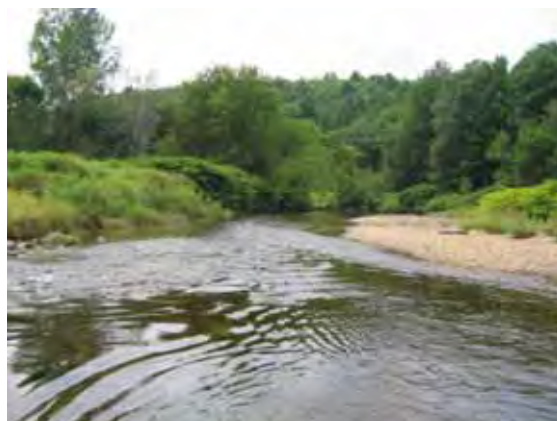
**Figure 7.17. Typical channel in M14-A**

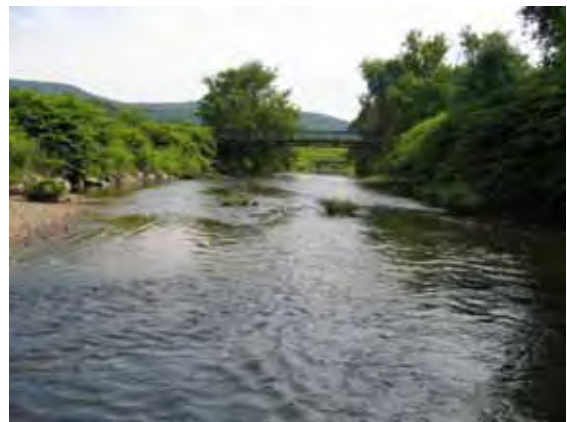
**Figure 7.18. Typical channel in M14-B**

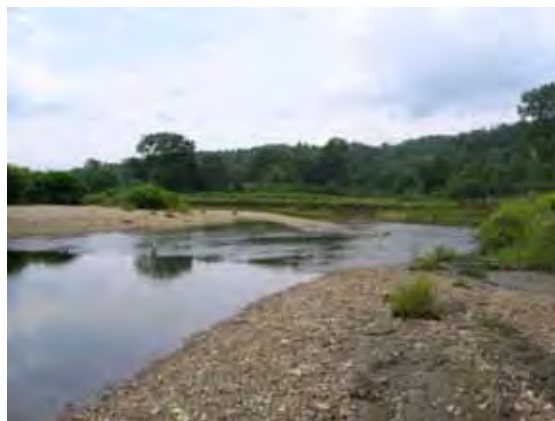
Deposition along Segment M14-C is much more pervasive than in other segments in M14 (Figure 7.19). This deposition has affected the reach enough to cause diagonal bars and steep riffles to form. There are also eight large point bars and four side bars. Channel planform has changed in M14-C as shown by the presence of an island, flood chute and a channel avulsion. Both the RGA and the RHA scored in the “fair” category. The RGA was fair as a result of major historic degradation, aggradation, widening, and planform adjustment. Numerous depositional features, exposed substrate,

**Figure 7.19. Large point bars, bank erosion and lack of buffer in segment M14-C**

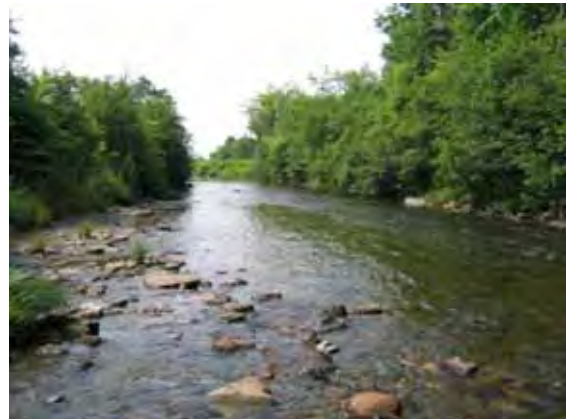
Figure 7.20. Straightened section of segment M14-D

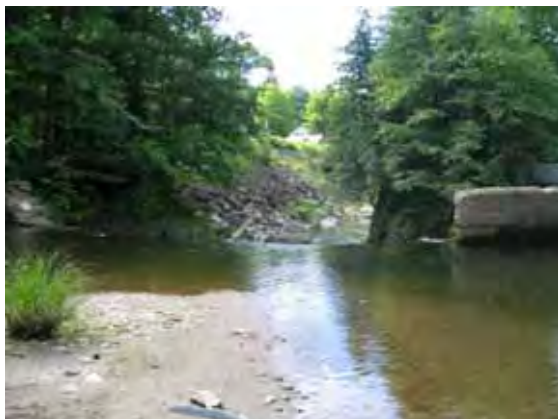
**Figure 7.21. Old dam grade control is constricting channel and causing sediment deposition upstream in M15-A.**

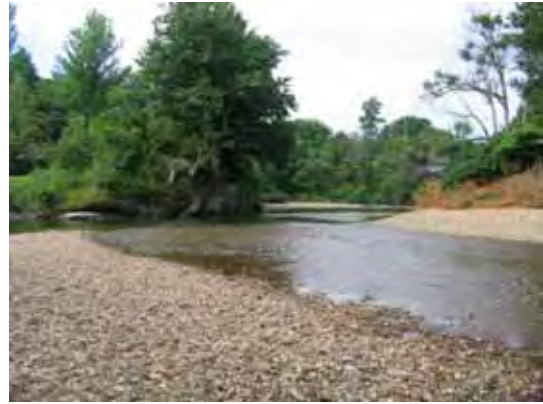
**Figure 7.25. Large point bars within Segment M15-D**

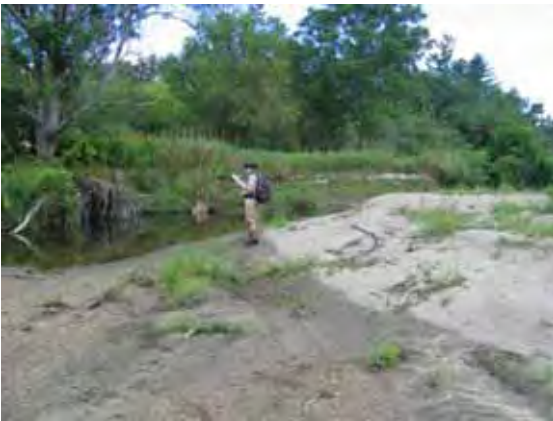
**Figure 7.27. The large sand point bar reflects the major aggradation in M16-C.**

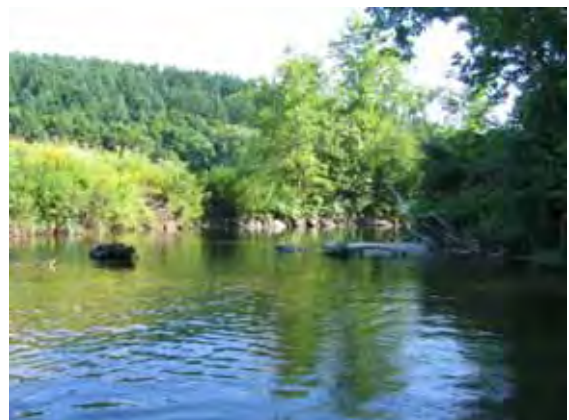
**Figure 7.28. Beaver dam influence in M16-B**

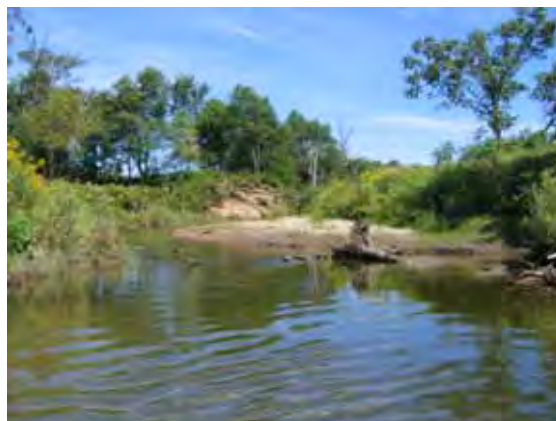
**Figure 7.29. Bank erosion and point bar in M17**

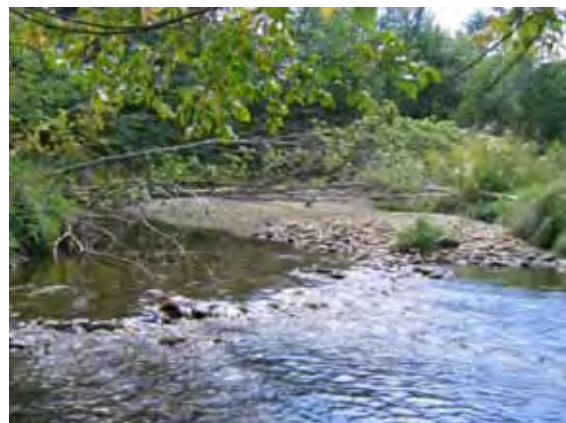
**Figure 7.35. Steep riffle and point bar within Segment M21-A.**

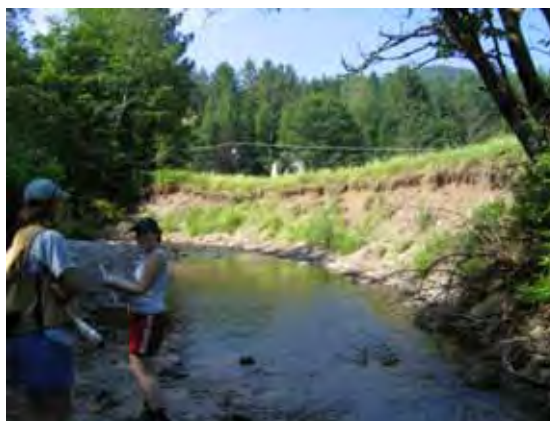
**Figure 7.36. Lack of buffer along western bank causing bank failure in Reach T4.01**

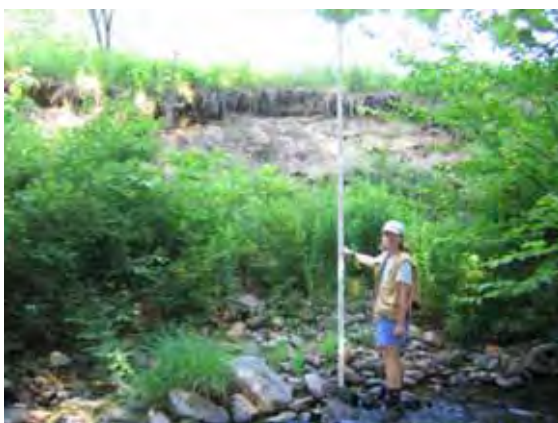
**Figure 7.37. Mass failure 12 feet high along western bank in Reach T4.01**

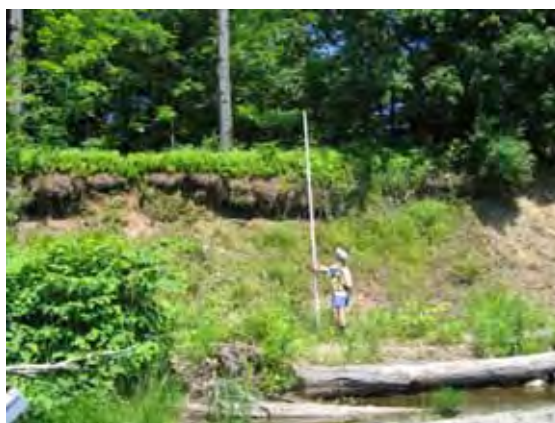
**Figure 7.38. Mass failure 20 feet high along eastern bank in Reach T4.01**

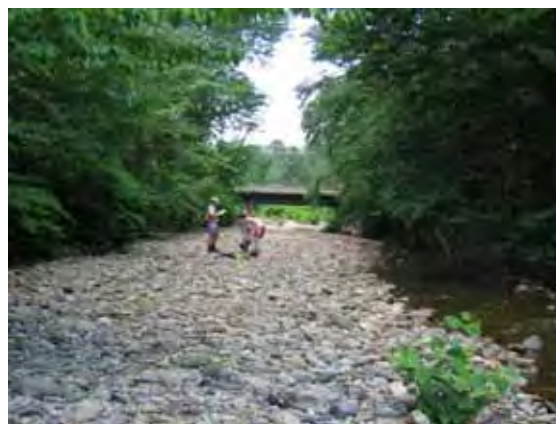
**Figure 7.39. Major aggradation shown by very large side bar in Reach T4.01**

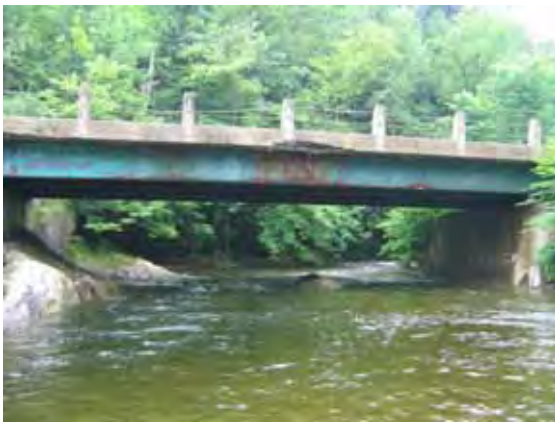
Figure 7.40. Bridge crossing of Nebraska Valley Road constricting Reach T4.02

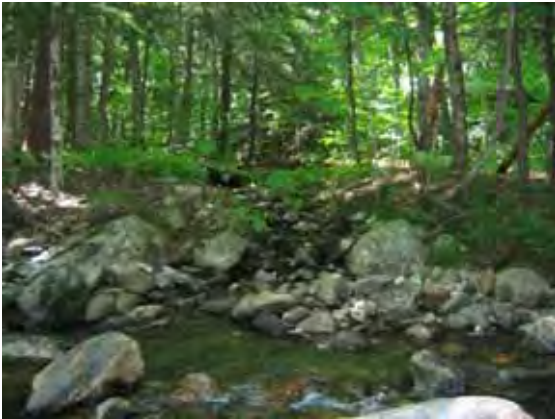
Figure 7.44. Rejuvenating tributary in Reach T4.04

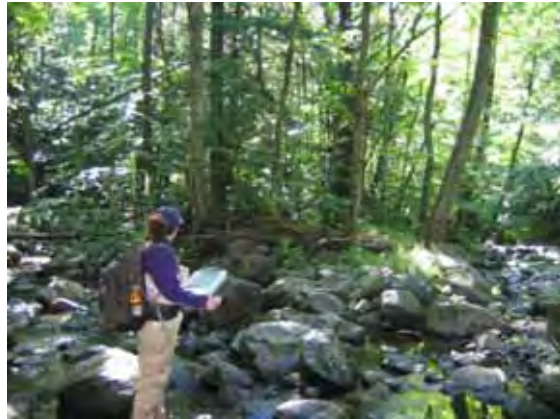
Figure 7.45. One of many islands showing major planform adjustment in Reach T4.04

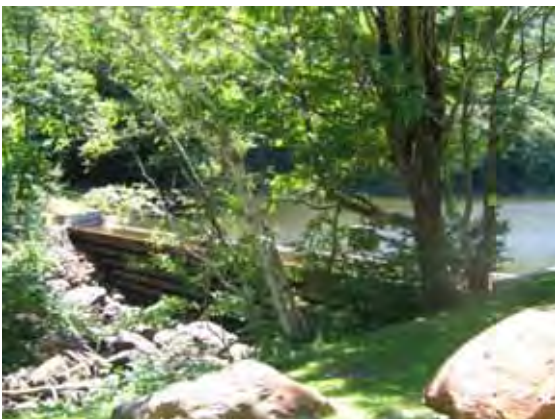
Figure 7.46. Lake Mansfield Trout Club dam at upstream end of T4.05

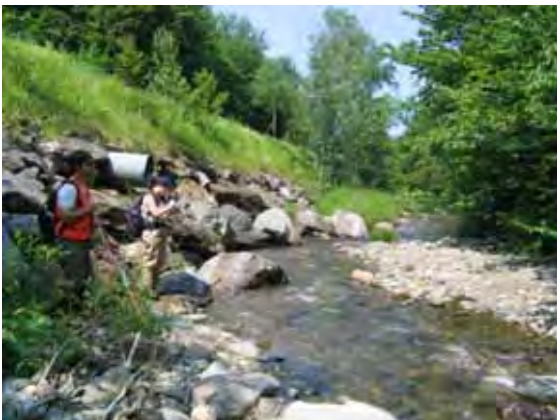
**Figure 7.52. Rip-rap armoring, lack of buffer, and stormwater input in Segment T6.03-B**

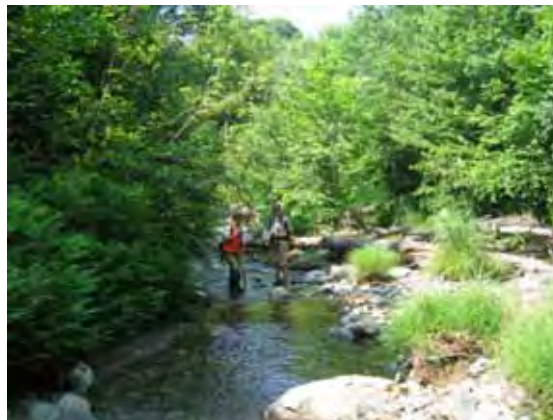
**Figure 7.53. Major aggradation in Segment T6.03-C**

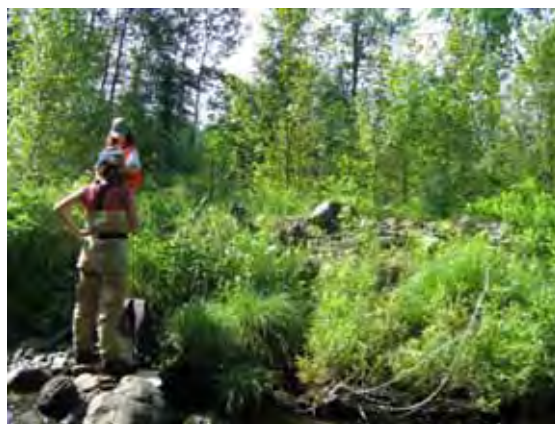
Figure 7.54. Berm with fill preventing floodplain access in Reach T6.04

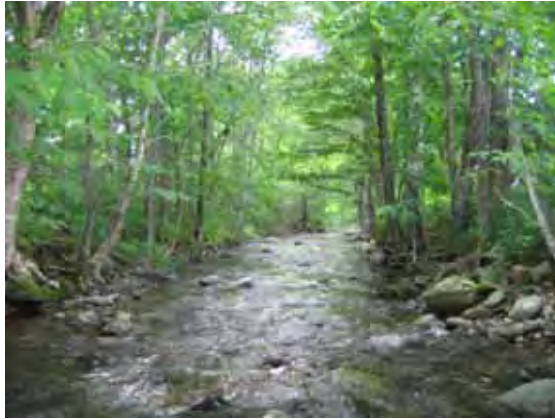
Figure 7.55. Straightened section of Reach T6.05

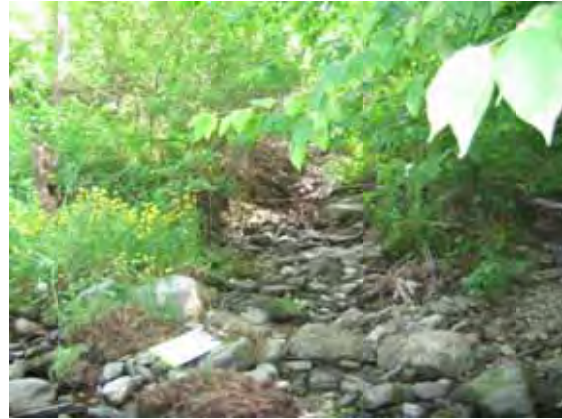
Figure 7.56. A rejuvenating tributary indicates that T6.05 has incised

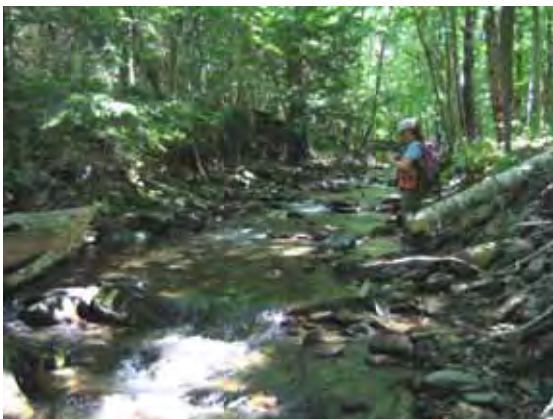
Figure 7.57. Typical channel in Segment T6.06-A

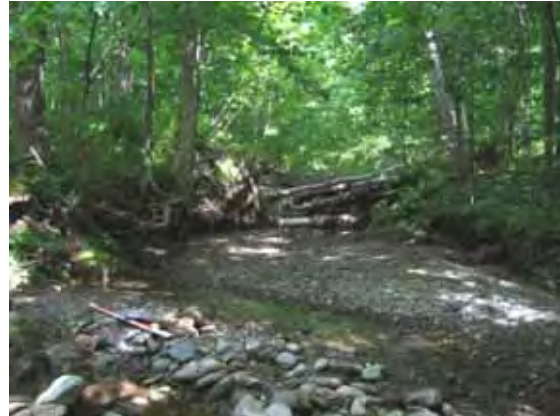
Figure 7.59. Outlet of channel avulsion in Segment T6.06-A

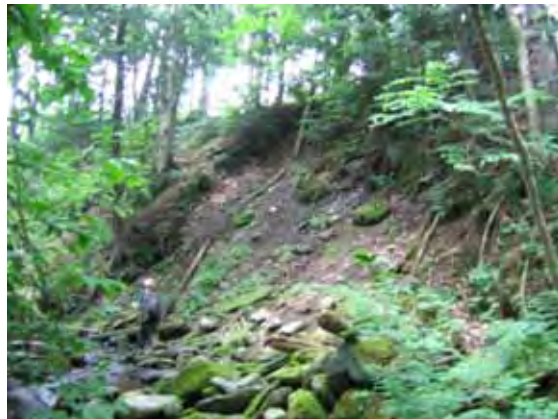
Figure 7.61. Mass failure in T6.07

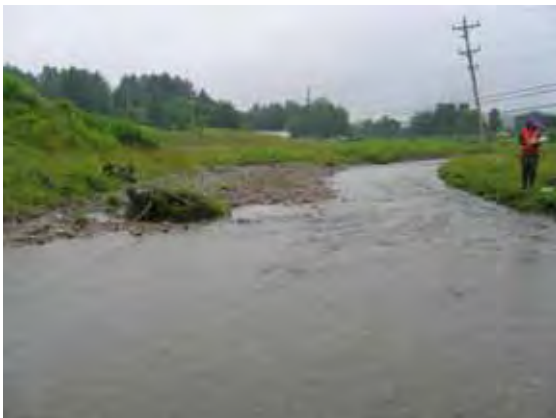
**Figure 7.2 Over widened channel in cross section of T8.01-B**

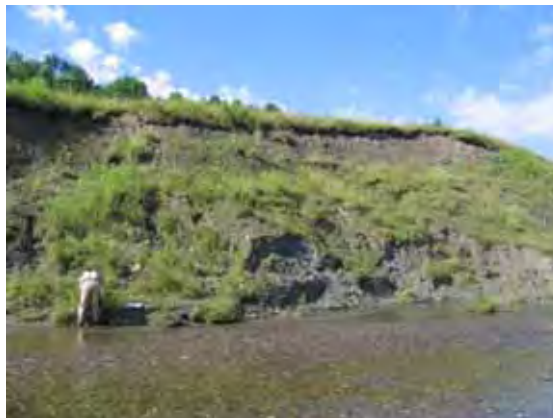
**Figure 7.63. Mass failure acting as a major sediment source in Moss Glen Brook in T8.01-B**

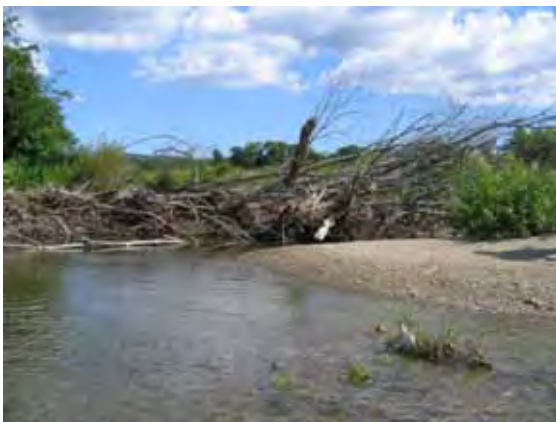
**Figure 7.64. Beaver dam causing deposition in T8.01-A**

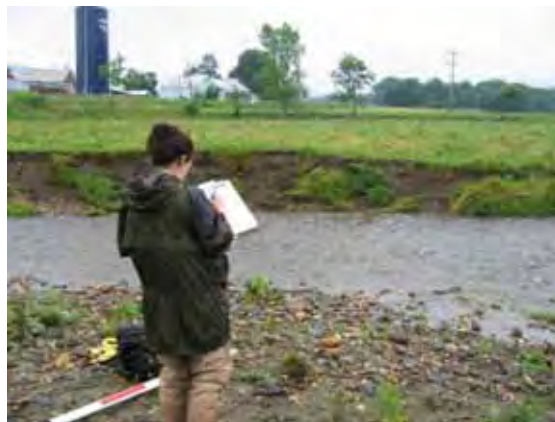
**Figure 7.65. Lack of buffer and severe bank erosion in cow pasture area in T8.01-B**

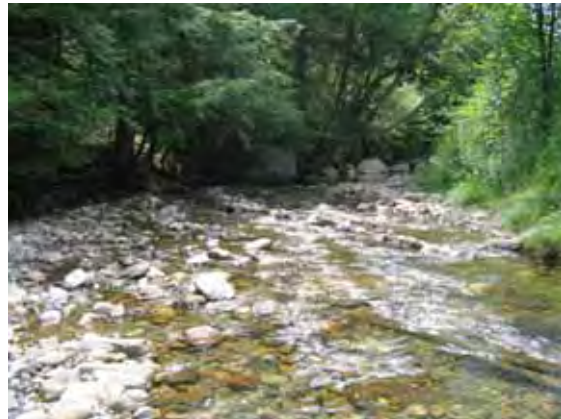
**Figure 7.66. Straightened section of segment T8.02-B**

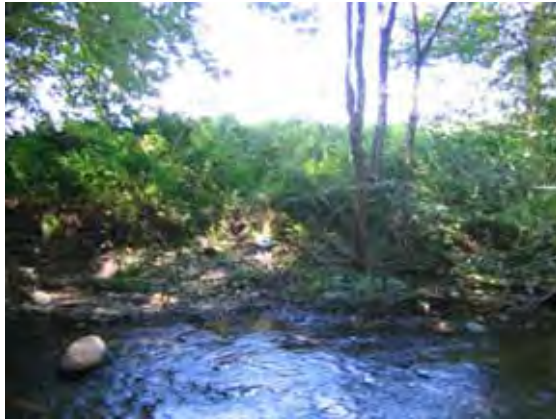
**Figure 7.67. Lack of buffer in Reach T8.03**

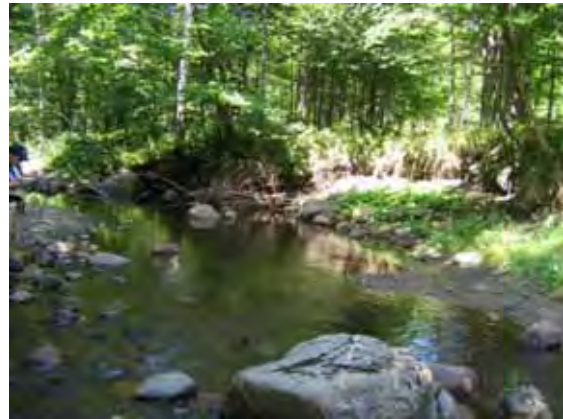
**Figure 7.68. Bank erosion on northern bank in Reach T8.03**
