# **West Branch of the Little River Corridor Management Plan**

**Stowe, Vermont**

Prepared by:  
The Lamoille County Planning  
Commission

January 22, 2007  
Version 1.2

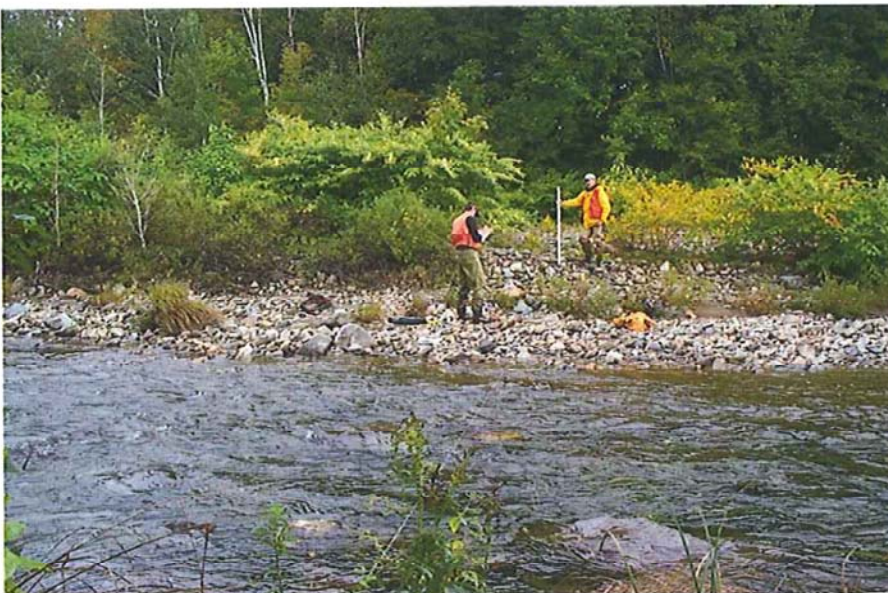
**Figure 2. Cross section performed during Phase 2 assessment**

A Phase 2 geomorphic assessment was conducted by Bear Creek Environmental (BCE) during September and October of 2005. The Phase 2 assessment provides detailed analysis of stream type, stage of channel evolution, geomorphic condition and habitat conditions of the river. Details of the findings of this assessment are available in Appendix A.

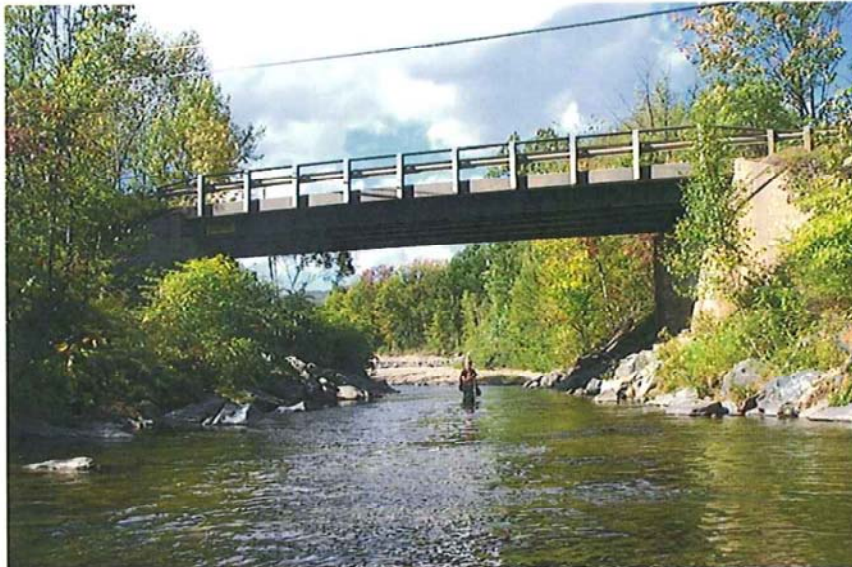
**Figure 4. Luce Hill Bridge**

This segment is also exhibiting signs of widening and creating a floodplain at a lower elevation, and is extensively armored with rip-rap, similar to reach 1. The Luce Hill Bridge is the cause of significant obstruction of sediment movement in this reach (see Figure 4, page 18). The riparian corridor in this segment is dominated by commercial and residential land uses.

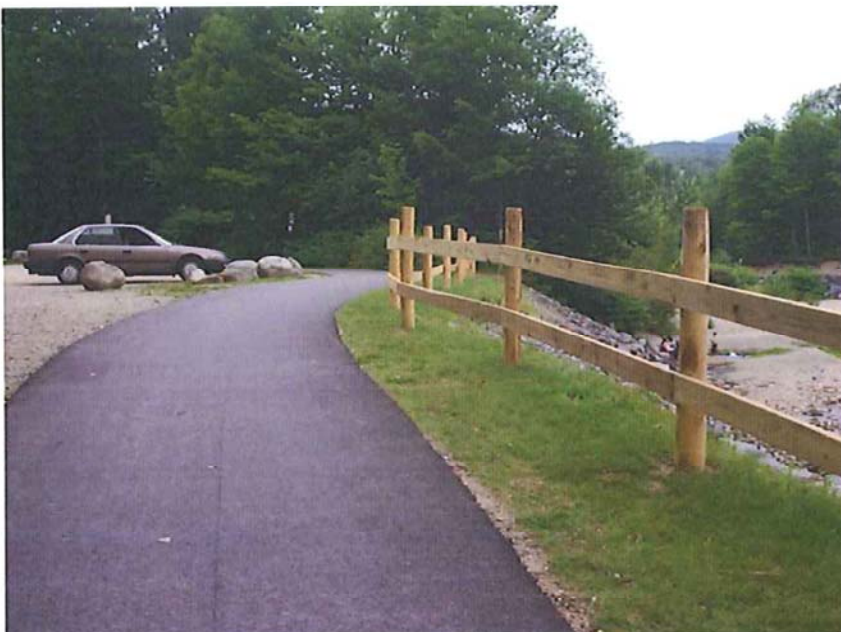
**Figure 7. Bike Path on bank of river**

The bike path is an encroachment along much of the West Branch. In such places, consideration should be given to relocating the bike path to a site outside of the floodplain as not to encroach on the river corridor and cause maintenance issues, particularly bank armoring (see figure 6). It is recommended that the Town of Stowe revise its Recreation Plan and Recreation Lands Management Plan to place higher

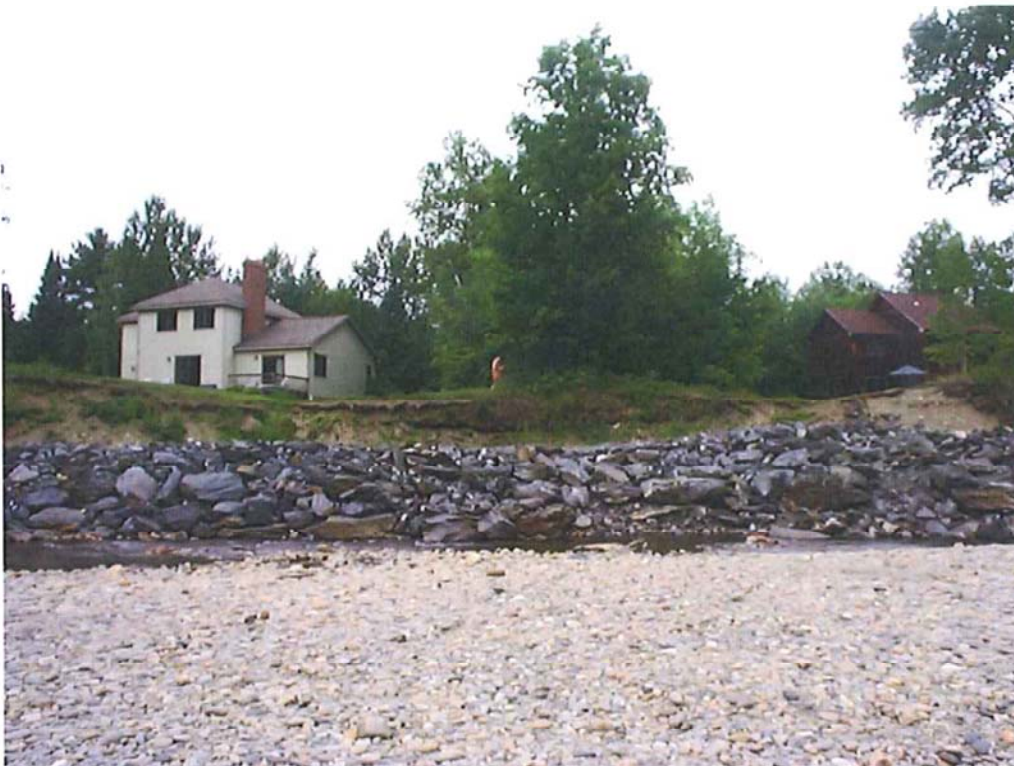
**Figure 9. Rip-rapped erosion threatening residential structures on the West Branch**

These channel management activities created a vicious feedback loop wherein the river would either transfer its energy from an armored bank to erode an unprotected area, or simply incise more deeply, thereby cycling the channel evolution process back to Stage II. This served to undermine and outflank much of the bank armoring that was performed. It is estimated that as much as 75% of bank armoring constructed since 1973 has failed and been replaced at least once; and as much as 33% failed and has been replaced more than once. In today's dollars, public and private expenditures on bank armoring along the West Branch would total upwards of \$1.5 million. This cost should be considered in addition to the extensive erosion and inundation related property damages that have been experienced along the West Branch over the past quarter century.

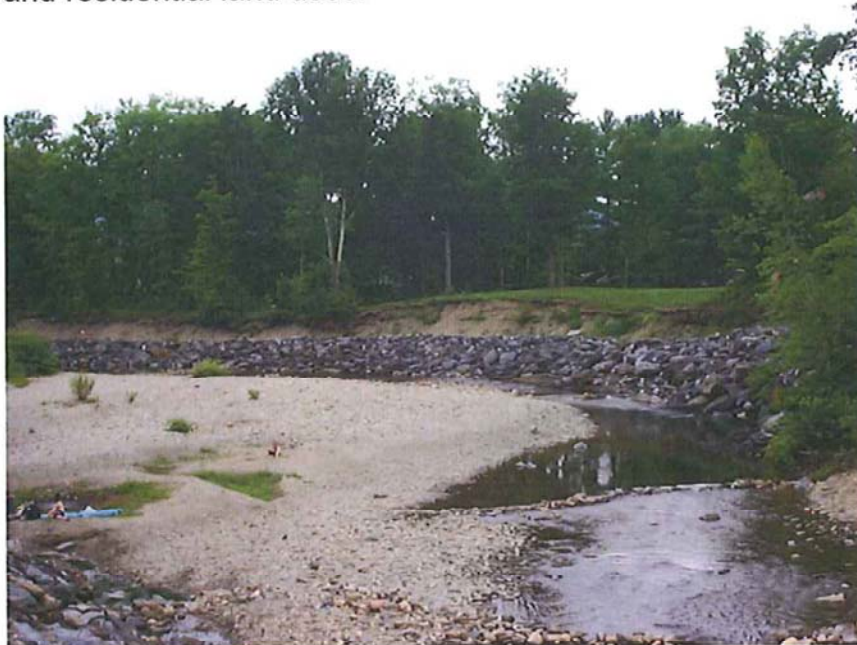
**Figure 12. Sediment upstream of Luce Hill Bridge**

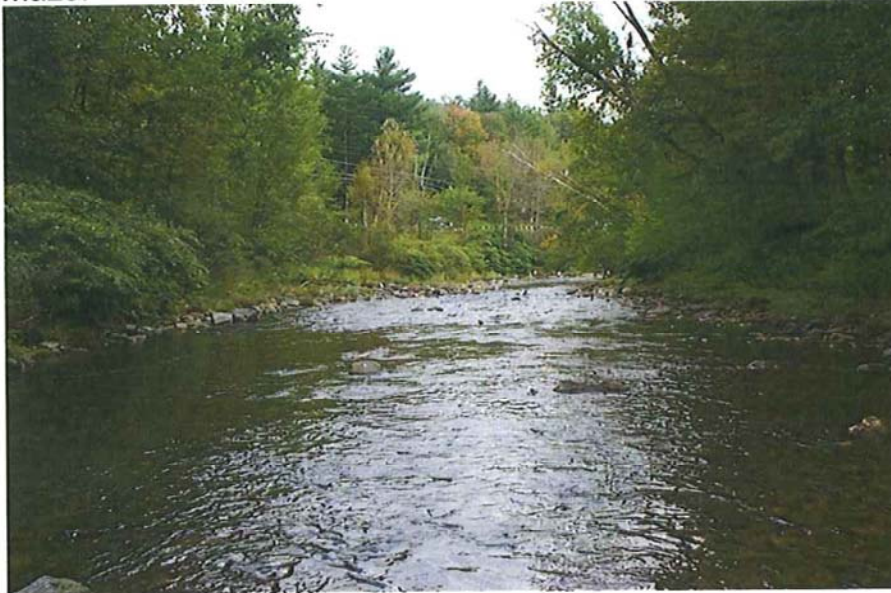
**Figure 13. Reach 3**

This segment has reestablished a small floodplain and sediment is being stored in point bars. It is further along in channel evolution than the segment downstream, and is relatively wide and shallow.

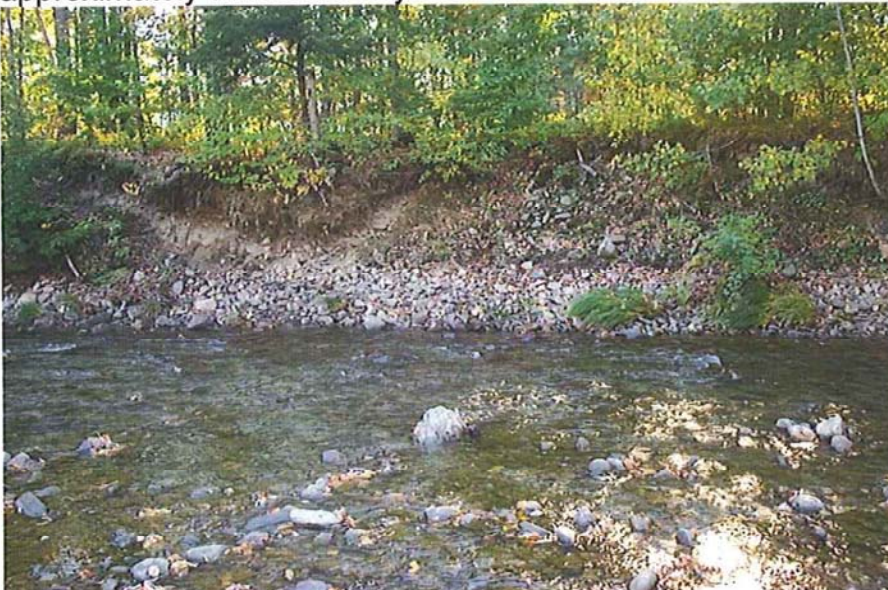
**Figure 14. Erosion on Reach 4**

This segment is highly entrenched. There is high bank erosion and very little sediment storage. This segment would benefit from the creation floodplain to help prevent further degradation and widening. Although many sections of this reach have a healthy riparian buffer that should be protected, continued erosion and loss of streambank trees can be expected unless a floodplain bench is created.

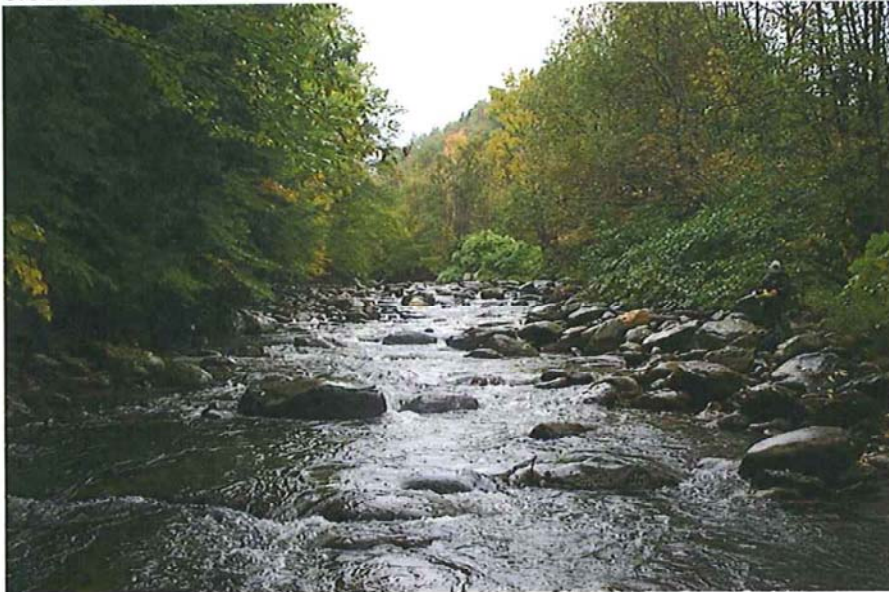
**Figure 16. Reach 6**

This is a steep, bouldery, partially channelized reach that is providing no sediment storage and may even be producing sediment from active incision and bank erosion. It is very dynamic and has resulted in a number of significant erosion threats to developed property located within the corridor in the past. It is a high priority to avoid additional development within the undeveloped corridor.

This segment has been affected by historic channel straightening and floodplain encroachment especially on the left bank. Opportunities for reducing these encroachments and reestablishing floodplain should be explored. Considering the amount of existing development in the left corridor, the right side of the corridor should be given higher priority for conservation to compensate for the lack of room on the left. Also, plantings should be a priority for the left bank to protect structures that are very close to the river.
