[EXTERNAL] Re: 1100 Pucker Street demo request - zoning permit application

Property Inspection Report For:

Property address: **(Barn Only)**
1100 Pucker St
Stowe VT [05672-4493](tel:05672-4493)

Barn / structure

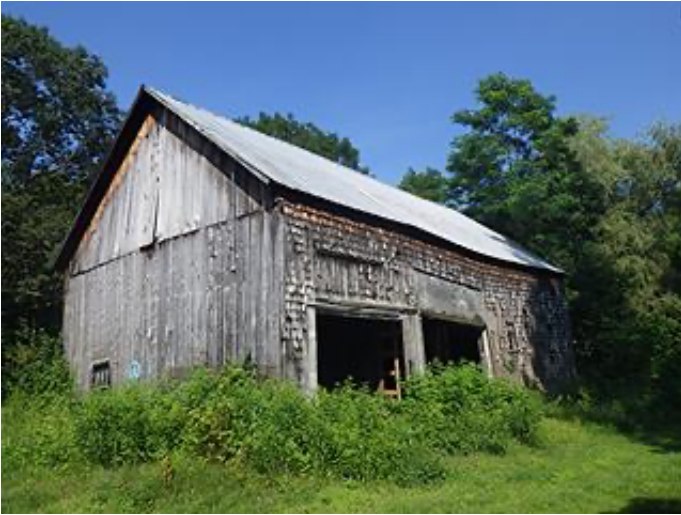
Photo 2-1

The 19th-century post-and-beam barn has deteriorated beyond practical repair: widespread dry rot has hollowed sills, posts, and girts; several key members are decayed, missing, or split; and the roof framing is sagging and partially collapsed, creating an imminent risk of structural failure and potential injury. Restoring this level of decay would require hand-hewn timber replacements, custom joinery and extensive shoring at a cost far exceeding the barn's historic value or any reasonable preservation budget. For public safety and fiscal responsibility, I recommend demolition and if possible salvaging any sound historic timbers for archival use.

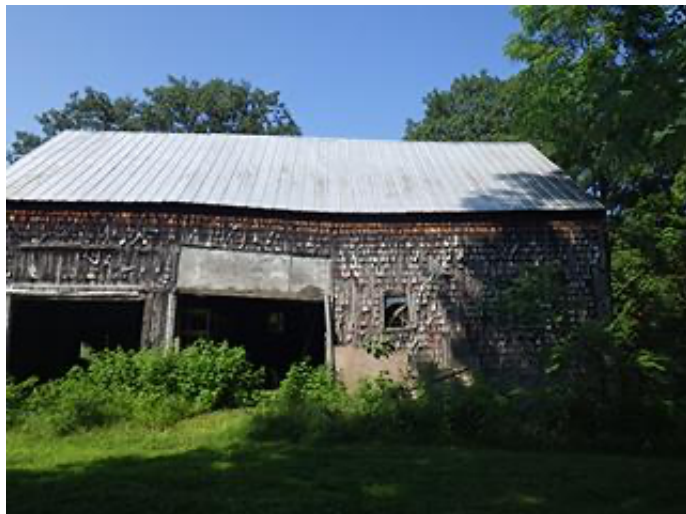
Photo 3-1

The roof surface appeared in poor condition. rusted panels, loosened fasteners, gaps in panels etc.

Support structure is inadequate, it has poor support continuity to the earth due to decay, broken support members etc., resulting in dramatic deflection in the roof line.
