# **Little River Corridor Plan**

**Stowe, Waterbury, Morristown, Worcester,  
Bolton, Underhill and Cambridge, Vermont**  
**Draft April 21, 2010**

Bear Creek Environmental, LLC  
297 East Bear Swamp Road  
Middlesex, Vermont 05602

The Lamoille County Planning Commission  
632 LaPorte Road  
Morrisville, VT 05661

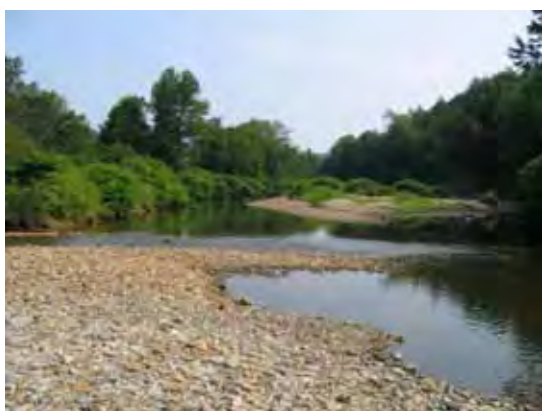
The presence of a mid-channel bar, point bars and large side bars indicates that M07 is also depositional (Figure 7.4). Erosion is also common along both banks. The dominant buffer width on both sides of the channel is greater than 100 feet in width; however, about ¼ of the west bank has buffers less than 25 feet (Figure 7.5). These areas of minimal buffer are associated with hay fields. CREP is one possible program that could be used to improve water quality in Reach M07 by establishing buffers adjacent to hay fields.

**Figure 7.4. Depositional features and wide channel in M07**

The channel width in this gravel dominated “C” reach has deviated from its reference of 84 feet to 111 feet indicating major widening, which explains the deposition within the segment. The RGA rated in the “fair” category due to extreme historic degradation, and major aggradation, widening, and planform adjustment. Disturbance of natural conditions has impacted the habitat in this M07 resulting in a “fair” score for the RHA. The lack of vegetation on the western bank and within the riparian buffer, as well as bank erosion, contributed to the habitat condition. The east bank along reach M07 is providing higher quality habitat along than the west bank due to its well vegetated riparian buffer and protected banks.

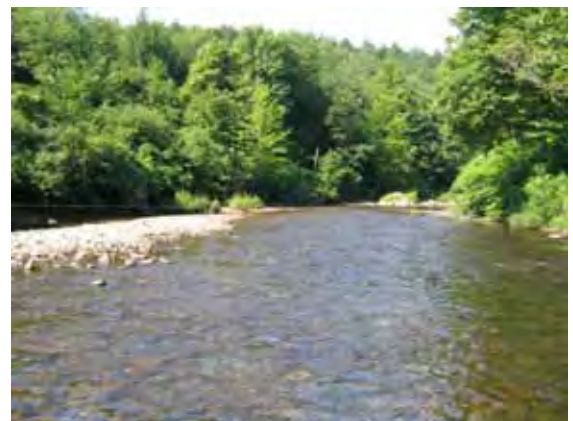
Many side bars, one mid-channel bar, two point bars, one diagonal bar, and one steep riffle were noted in the reach indicating that this reach is depositional (Figure 7.8). Reach M09 is a gravel dominated "C" channel in the F-III stage of channel evolution. The RGA scored "fair" due to extreme historic degradation and major widening and aggradation. Planform adjustment is a minor process. Channelization along Moscow Road, exposed substrates, deposition, bank erosion, and a narrow buffer width on the north bank are all factors that contributed to a RHA score of "fair".

**Figure 7.8. Side bars in Reach M09**

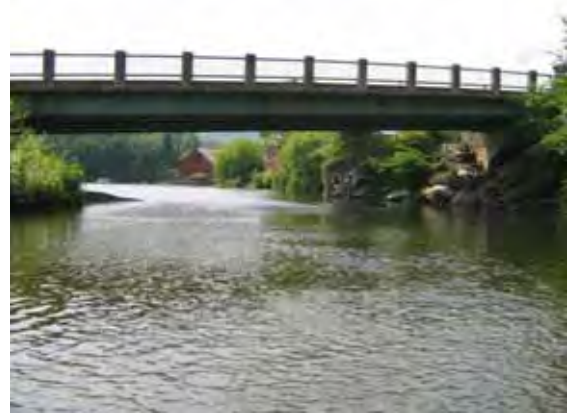
**Figure 7.11. Bridge at Moscow Road in Reach M11**

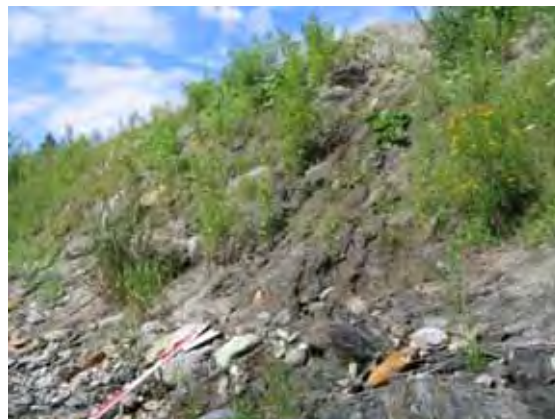
There is a bedrock grade control and an old dam (Figure 7.21) acting as a grade control in segment 15-A. The old dam is acting as a channel constriction and causing fine sediment to settle out upstream. The municipal sand storage is located on the western bank and there is significant bank erosion in the vicinity of this facility (Figure 7.22). A second parcel of land owned by the Town of Stowe, the wastewater treatment facility, abuts the northern bank of the Little River in segment M15-A and B.

**Figure 7.22. Bank erosion and lack of woody vegetation in the vicinity of the municipal sand storage facility**

There are several stormwater inputs including four road ditches and one field ditch. Most of Segment M15-A has been straightened and armored to protect development. Woody vegetation to help reduce bank erosion is lacking on both banks due to the presence of rip-rap and invasive bank vegetation. Buffers of less than 25 feet are present along the west bank (about 20 percent), but the dominant buffer width is 51 to 100 feet. The east side has a dominant buffer width of 26 to 50 feet. Residential is the dominant corridor land use on the east side, while industrial is dominant adjacent to the west bank.

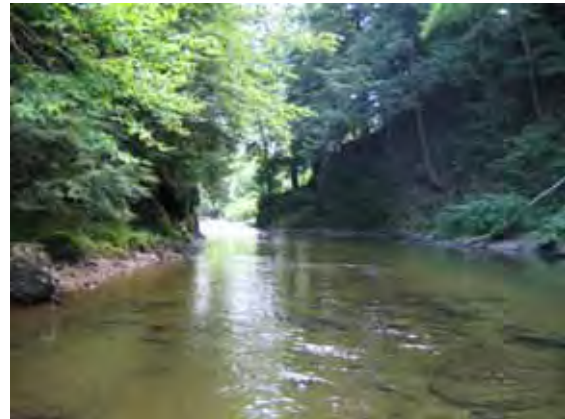
Segment M15-B is 559 feet long and is contained within a bedrock gorge (Figure 7.23). Due to the bedrock grade controls, Segment M15-B was not fully assessed. Since Segment M15-B is in a narrowly confined bedrock gorge with decent riparian buffers, it is presumed to be in reference condition. The western corridor is well forested, but the eastern corridor contains residential and commercial land use outside the valley wall.

**Figure 7.23. Reference condition of bedrock gorge in Segment M15-B**

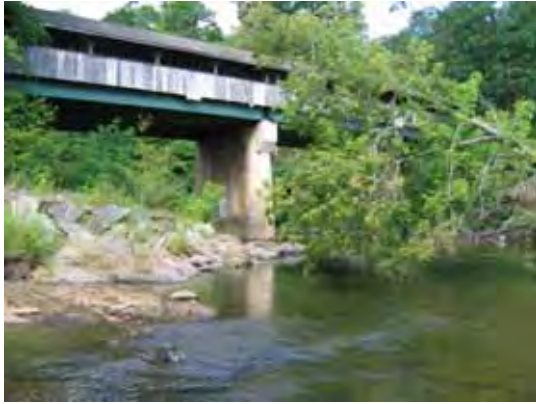
Segment M15-D begins where the Route 108 Bridge crosses (Figure 7.24). The valley opens up and the channel is less entrenched making it a gravel dominated “C” stream in stage III of the F channel evolution model. The presence of three large point bars, one side bar, and one mid-channel bar indicates M15-D is more depositional than the downstream segments in M15 (Figure 7.25). The west side of the river has a buffer less than 25 feet along 80 percent of its length from the presence of mowed lawn for commercial purposes. Erosion is minimal to moderate due to the presence of rip-rap on both banks.

**Figure 7.24. Route 108 bridge at downstream end of Segment M15-D**

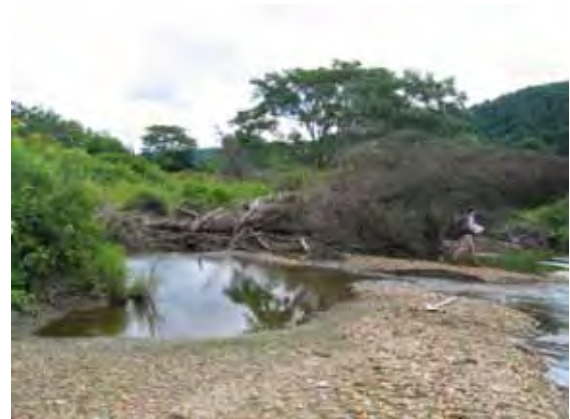
Reach M16 was separated into three segments to capture the characteristics of a beaver dam influenced sub-reach, M16-B. Differences in substrate size and depositional features were also factors in segmenting the reach. All three segments have beaver dams (Figure 7.26), but M16-B is most affected by the beaver dams.

**Figure 7.26. Beaver dam and deposition in M16-A**

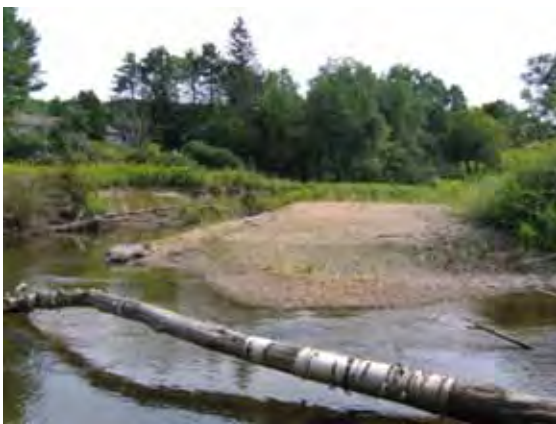
The lower segment, M18-A, begins about ½ mile downstream of the Little River Farm Road crossing and is 2,350 feet in length. The segment is currently undergoing major aggradation (Figure 7.30), major planform adjustment with minor widening. Planform adjustment was evident from the two avulsions which have cut off meander bends to form new channels.

**Figure 7.30. A large unvegetated gravel bar showing the major aggradation in M18-A.**

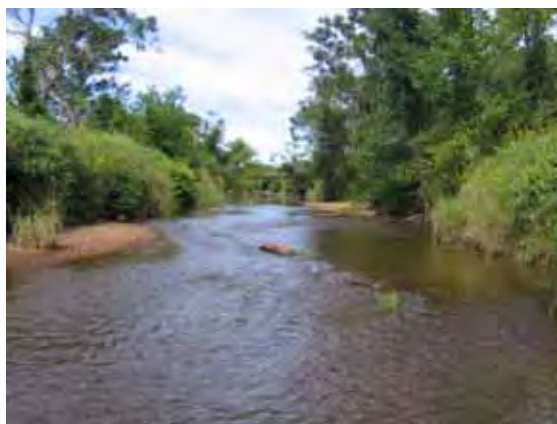
**Figure 7.31. Straightened section of M18-B**

Located downstream of the Little River Farm Road Bridge, segment M18-B is 514 feet in length and has been extensively straightened (Figure 7.31). Segment M18-B contains a diagonal bar and steep riffle, indicating that the segment is aggrading. However, aggradation, widening, and planform adjustment are minor adjustment processes for Segment M18-B.

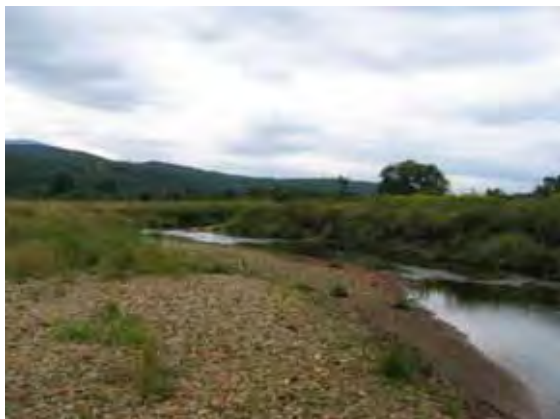
Reach M19 was divided into two segments due to changes in valley width and incision. The downstream segment (M19-A) is more incised than the upstream segment (M-19-B). The upstream valley is wider than downstream, although both segments still have very broad valleys. Both segments are gravel dominated "C" riffle-pool channels in stage F-III of channel evolution. M19 is very depositional with twenty steep riffles and numerous bars. (Figure 7.32).

Figure 7.32. Large point bar in M19-A

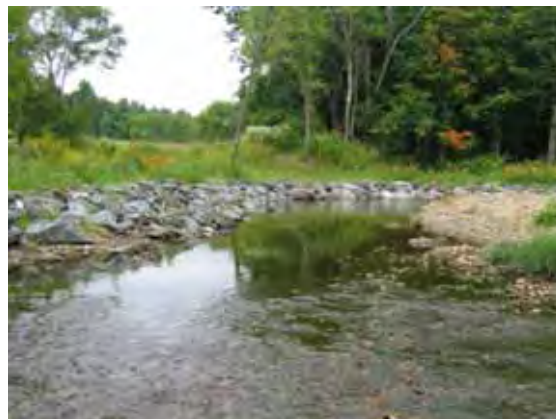
The percentage by length of erosion is greater in Segment M19-A indicating more widening than in Segment M19-B, although some of the outside bends in M19-B are eroding. Segment M19-B also has rip-rap armoring on its banks especially in the vicinity of Tansy Hill Road Bridge (Figure 7.33), while downstream there is none. This bridge is causing a channel and floodprone constriction. Just upstream of Tansy Hill Road Bridge, there is evidence of gravel mining. Dominant land use in M19-B is hay within the eastern corridor and forested in the western corridor.

Figure 7.33. Rip-rap along bank upstream of Tansy Hill Road Bridge in M19-B

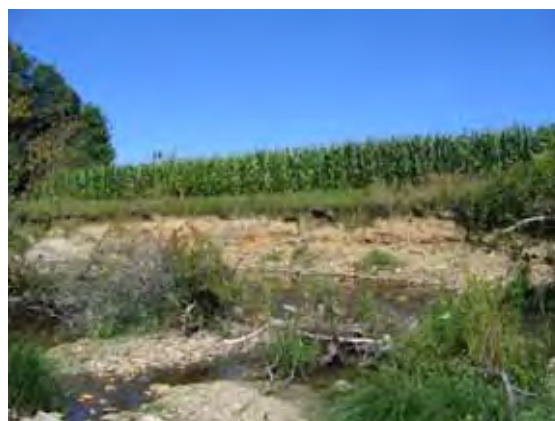
Figure 7.34. Severe erosion and lack of riparian buffer along east bank in Reach M20

The dominant buffer category is greater than 100 feet on both banks, but there are some areas where the buffer is less than 25 feet. Some of these areas with limited buffer are experiencing major erosion within the vicinity of crop fields (Figure 7.34). Forest is the dominant land use within the corridor in this reach, but the subdominant is crop in the eastern corridor and residential in the western corridor.

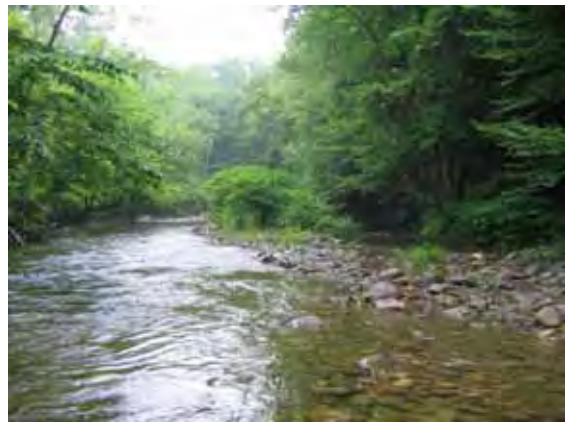
Reach T4.02 has experienced extreme historic incision, major aggradation and planform adjustment, and minor widening. Numerous steep rifles, diagonal bars, side bars, point bars and mid-channel bars indicate that some sediment is working its way down Miller Brook is getting deposited here (Figure 7.41). Many islands and flood chutes were observed indicating major planform adjustment. The RGA and the RHA were scored as "fair". The "fair" RHA rating was the result of numerous depositional features and the presence of invasive vegetation on the banks.

Figure 7.41. Island with diagonal bar and steep riffle along Reach T4.02

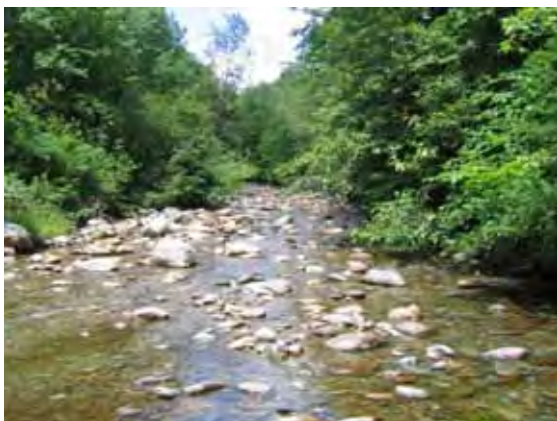
Reach T4.03 was broken into two segments due to differences in valley width, planform and slope, and depositional features. The stream type for both segments T4.03-A and T4.03-B is a cobble dominated "Cb" channel (Figure 7.42). Both segments are in stage III of the F channel evolution model. T4.03 is located along Nebraska Valley Road, which encroaches on the river corridor. Straightening has occurred on approximately  $\frac{1}{4}$  and  $\frac{1}{2}$  of the length of segments T4.03-A and T4.03-B, respectively, with windrowing having also taken place in segment T4.03-A.

Figure 7.42. Cobble dominated “Cb” channel in Reach T4.03

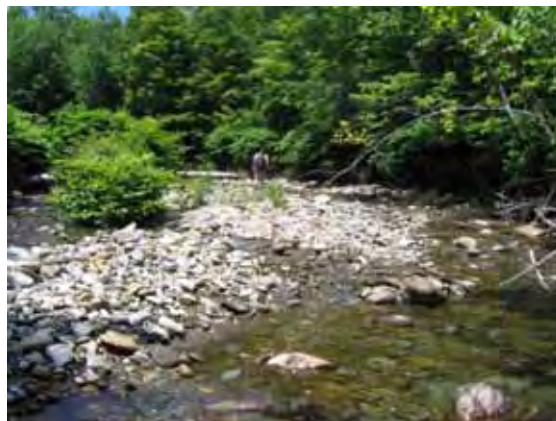
Segments T4.03-A and T4.03-B have historically incised, with greater incision in T4.03-B. Geomorphic processes in T4.03-A include minor historic incision and widening, major aggradation, and major planform adjustment. T4.03-B shows major historic incision and aggradation, while widening and planform adjustment are minor. Aggradation was evident from many steep riffles and diagonal bars along with other depositional features (Figure 7.43). The RGAs for both segments in T4.03 were scored in the “fair” category. The RHA was scored “fair” for T4.03-A and “good” for T4.03-B. In general, the RHA scored lower for T4.03-A primarily due to banks vegetated with invasive species, bank erosion, and lack of substrates for fish cover and epifaunal colonization.

Figure 7.43. Steep riffle and mid-channel bar showing major aggradation in Segment T4.03-A

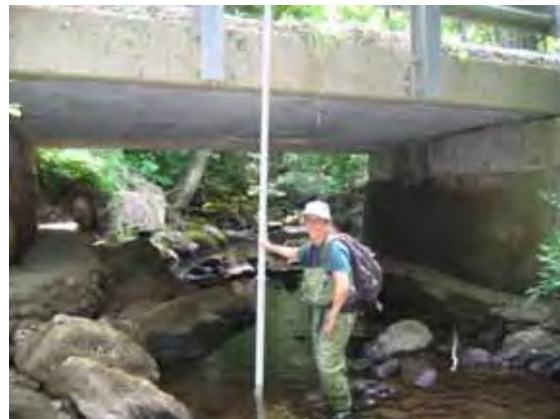
Figure 7.47. Constricting bridge at Nebraska Valley Road in Reach T4.05

Nebraska Valley Road encroaches upon the eastern corridor for 360 feet at the upstream end. The buffers for this reach are very well forested with a dominant width of greater than 100 feet and subdominant 51-100 feet just at the upstream end where Nebraska Valley Road encroaches upon the corridor. Large trees along the banks are holding soil in place, thereby resulting in little bank erosion. The dominant land use within both corridors is forest. The subdominant corridor land use is residential due to the road. Nebraska Valley road crosses Miller Brook again with a bridge that is constricting both the channel and the floodplain (Figure 7.47).

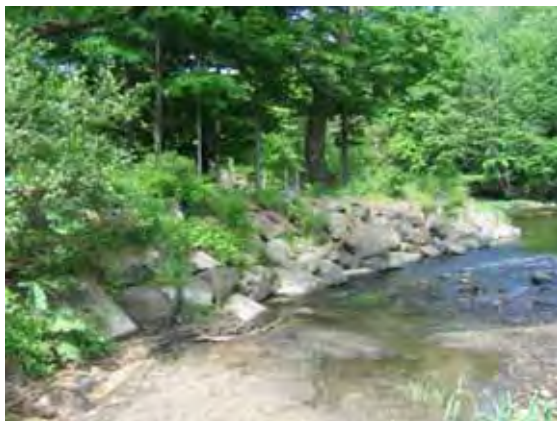
Approximately 70 percent of Reach T6.01 has been heavily bermed and about one-third has been armored with rip-rap and hard bank on the southern bank (Figure 7.48). Due to the armoring, there is little bank erosion on the southern bank. However, there is bank erosion along one-third of the northern bank. Roads and development encroach upon the corridor for approximately 60 percent of the channel length. Straightening has occurred along 80 percent of the reach. Gold Brook has also been dredged from its mouth up to VT 100. There is a bridge at the crossing at VT 100 causing both a channel and a floodprone constriction. The upstream part of this reach has a higher slope than near the mouth and includes a bedrock grade control (Figure 7.49).

**Figure 7.48. Rip-rap along southern bank in Reach T6.01**

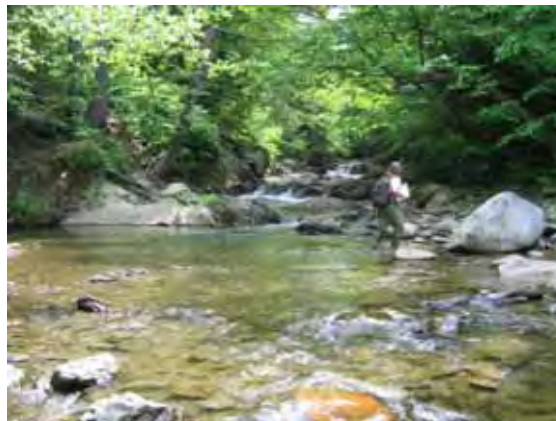
**Figure 7.49. Bedrock grade control in upper part of Reach T6.01**

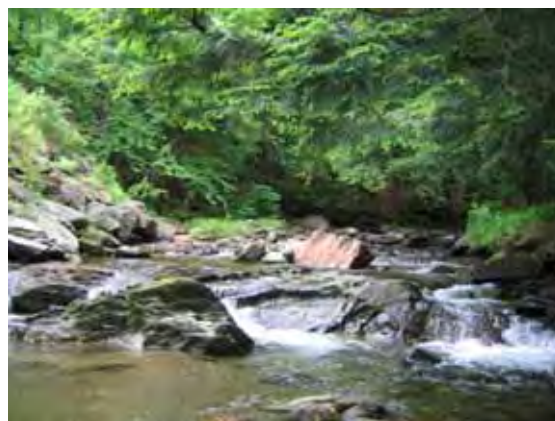
Reach T6.02 starts upstream of VT 100 and continues for about ½ mile. Reach T6.02 is a "B" type step-pool stream with no historic incision. There are many bedrock grade controls throughout Reach T6.02, thereby preventing downcutting of the bed (Figure 7.50). The bedrock in T6.02 is also causing channel constriction in four locations.

**Figure 7.50. Bedrock grade control in Reach T6.02 preventing incision in this segment**

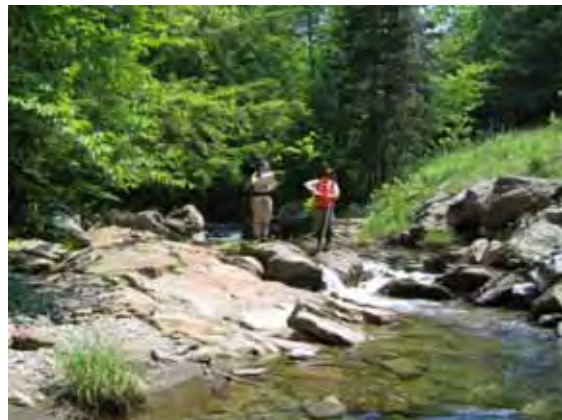
Segment T6.03-A is one-quarter mile long and begins where the southern side has road encroachment, buffers less than 25 feet, and is straightened and armored. The bedrock grade control in T6.03-A is preventing incision in this segment (Figure 7.51).

**Figure 7.51. Bedrock grade control in Segment T6.03-A**

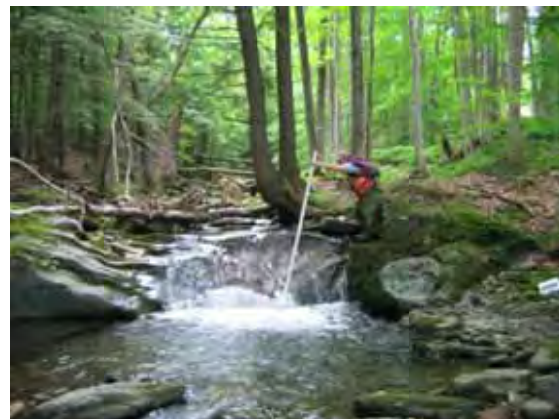
There has been a human caused change in valley width in both segments due to North Hollow Road. Approximately ½ of T6.06-A is straightened with possible windrowing, but T6.06-B is not straightened. Except for areas where development and North Hollow Road encroaches the corridor, the buffers are wide and well vegetated. Berms are located in both segments totaling approximately 600 feet. There are also several grade controls and bedrock constrictions (Figure 7.58).

Figure 7.58. Bedrock grade control and channel constriction in T6.06-B

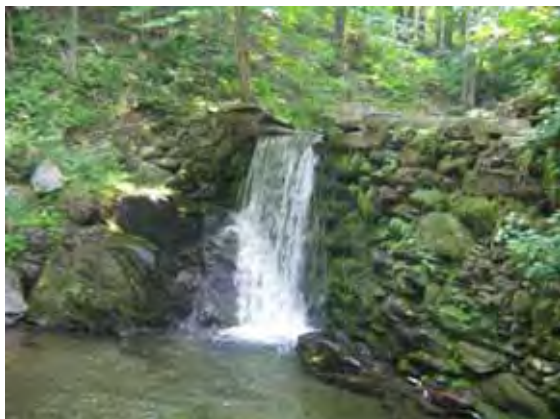
Reach, T6.07 begins about 250 feet downstream of the North Hollow Road crossing and continues in between North Hollow Road and Putnam Forest Road for about another ½ mile. There has been a human caused change in valley width due to North Hollow Road and Putnam Forest Road, which encroach approximately 60 percent of the reach by length. Channel straightening has occurred along about ½ of T6.07. There are many bedrock constrictions and grade controls including an old rock dam at the downstream end which is a fish passage issue and has caused significant scour just downstream (Figure 7.60). Two mass failures within T6.07 are providing a sediment source for the channel (Figure 7.61).

Figure 7.60. Old rock dam grade control in T6.07

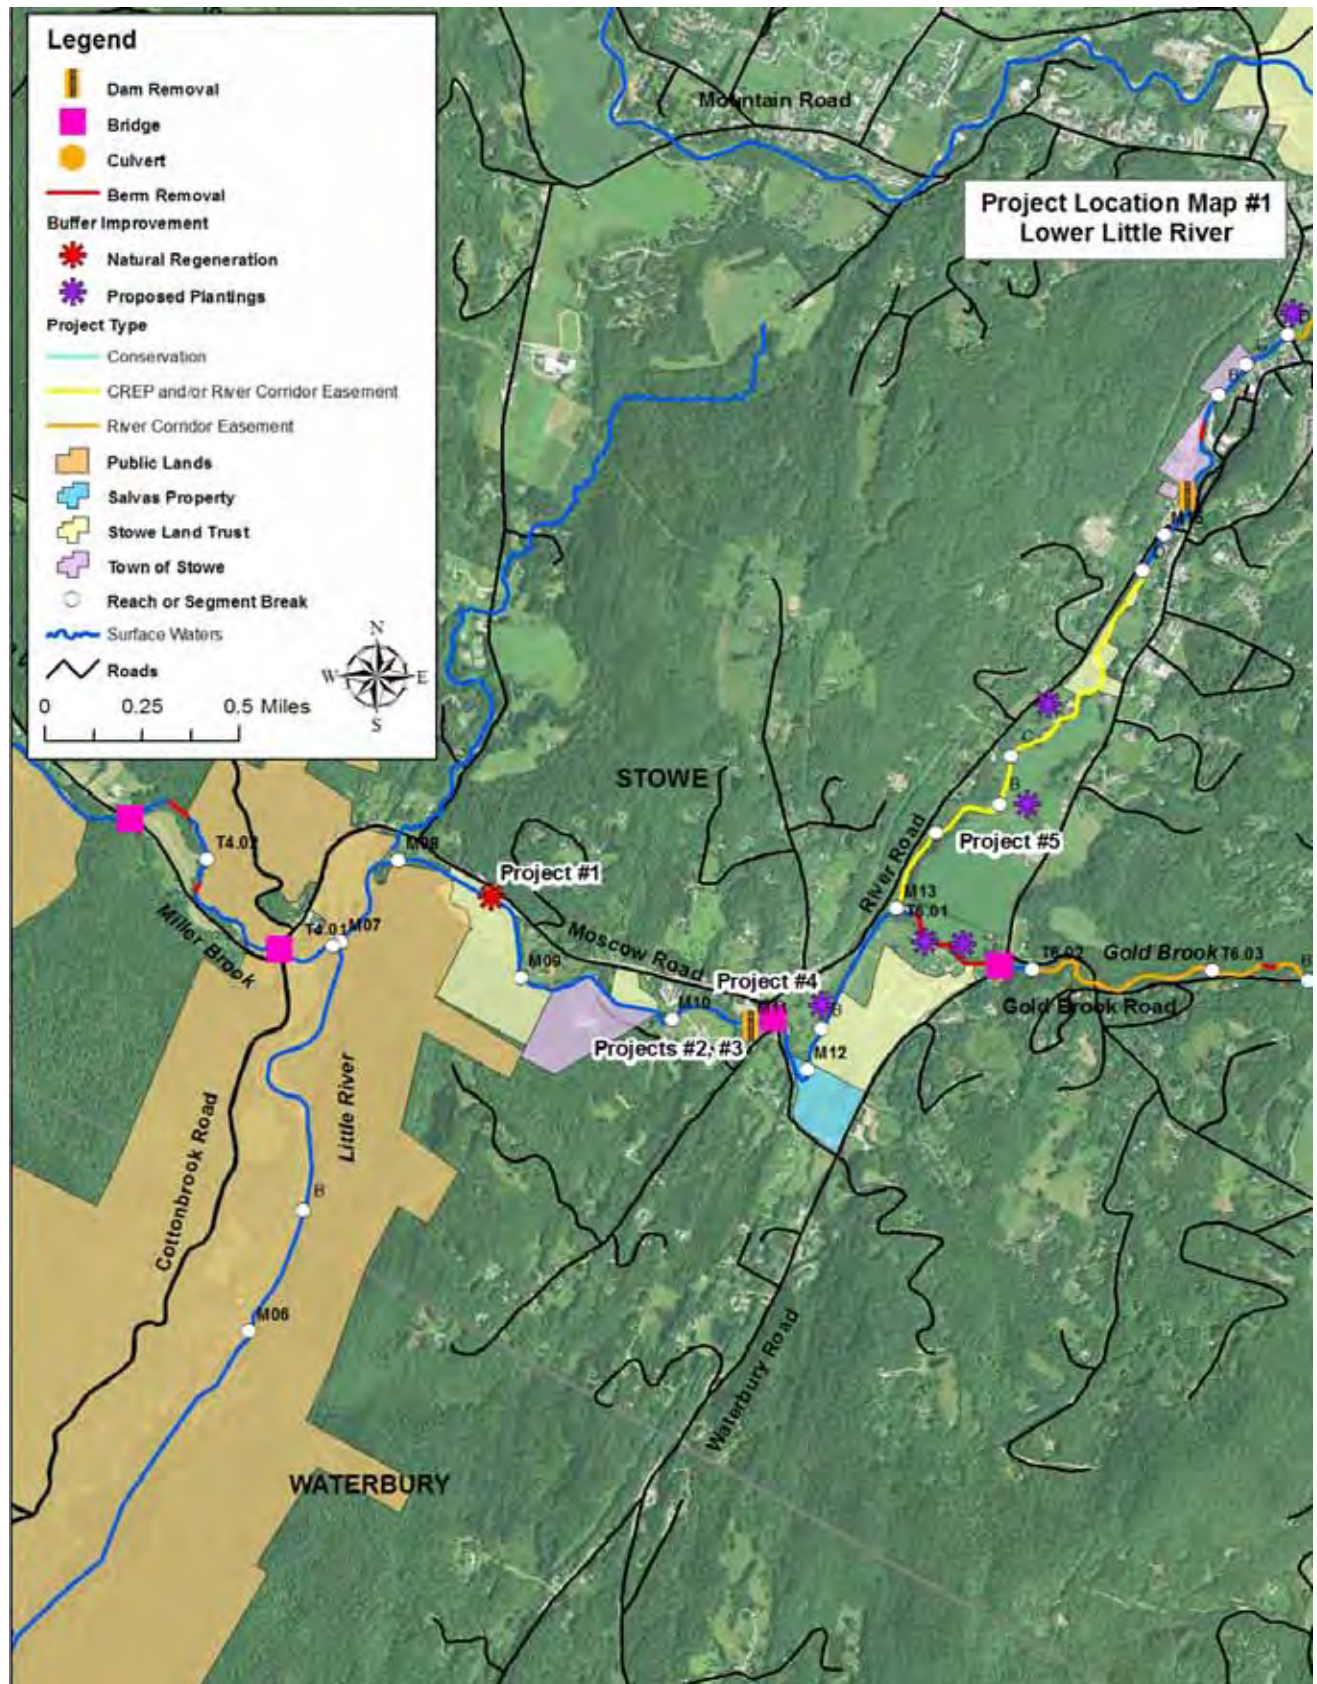
Figure 7.68. Proposed restoration and protection projects for Lower Little River mainstem

Lower Little River (see Figure 7.68 and Table 6)

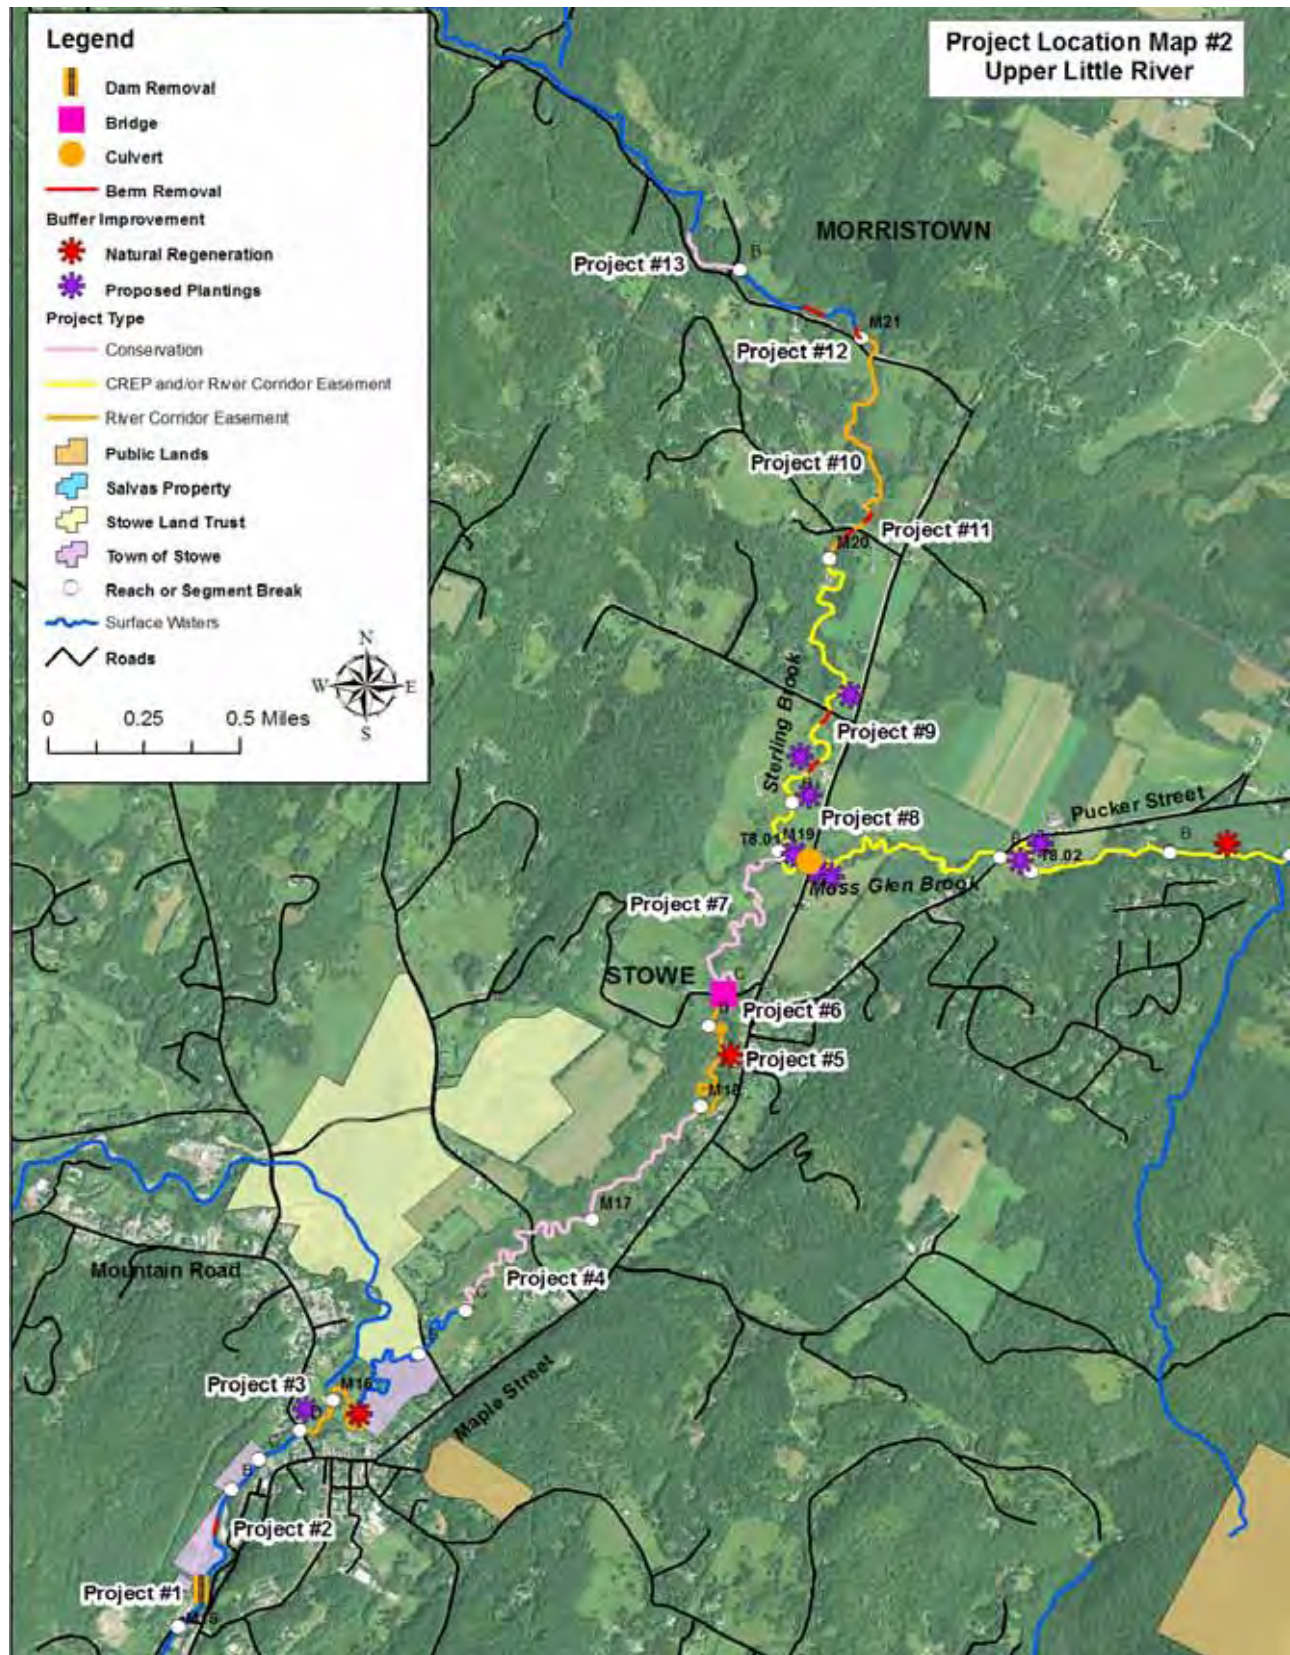
Figure 7.69. Proposed restoration and protection projects for Upper Little River mainstem

Upper Little River (see Figure 7.69 and Table 7)

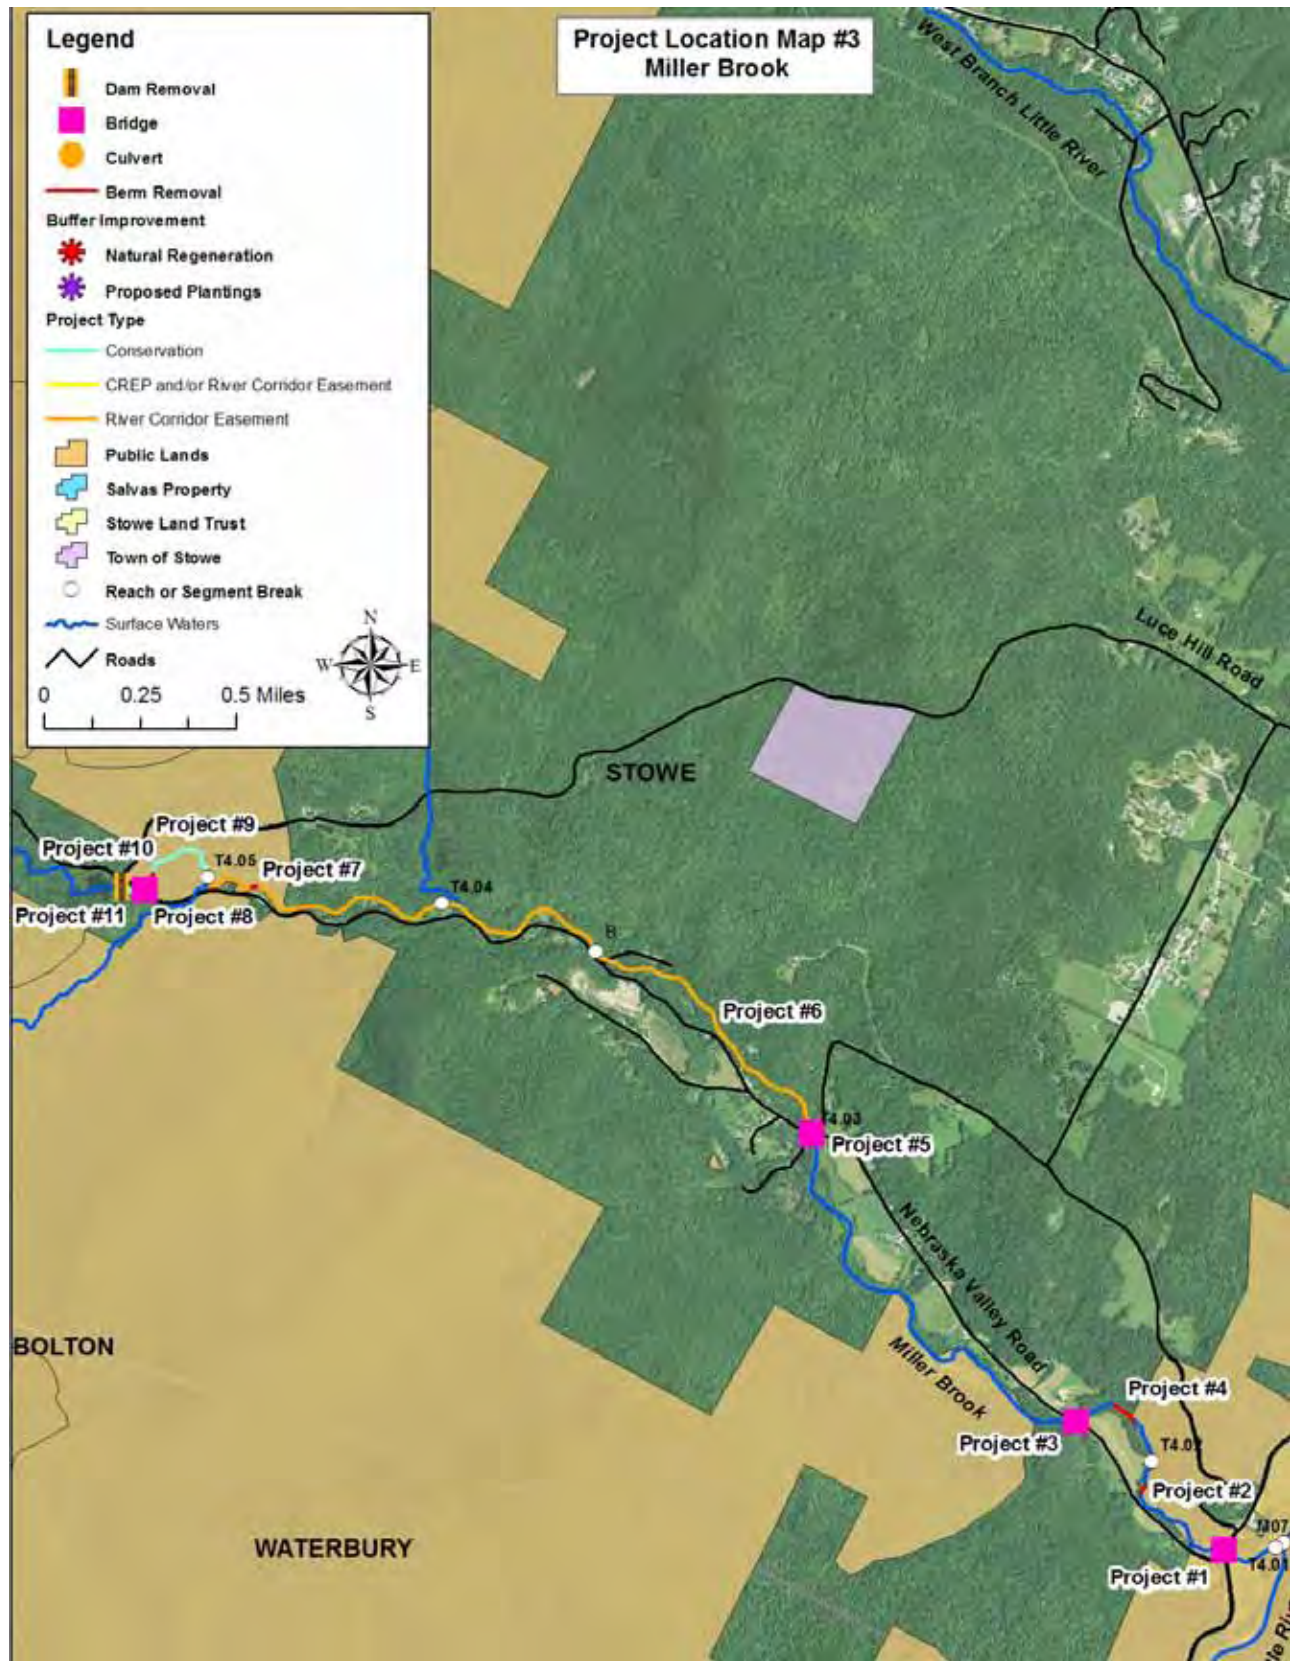
Figure 7.70. Proposed restoration and protection projects for Miller Brook

Miller Brook (see Figure 7.70 and Table 8)

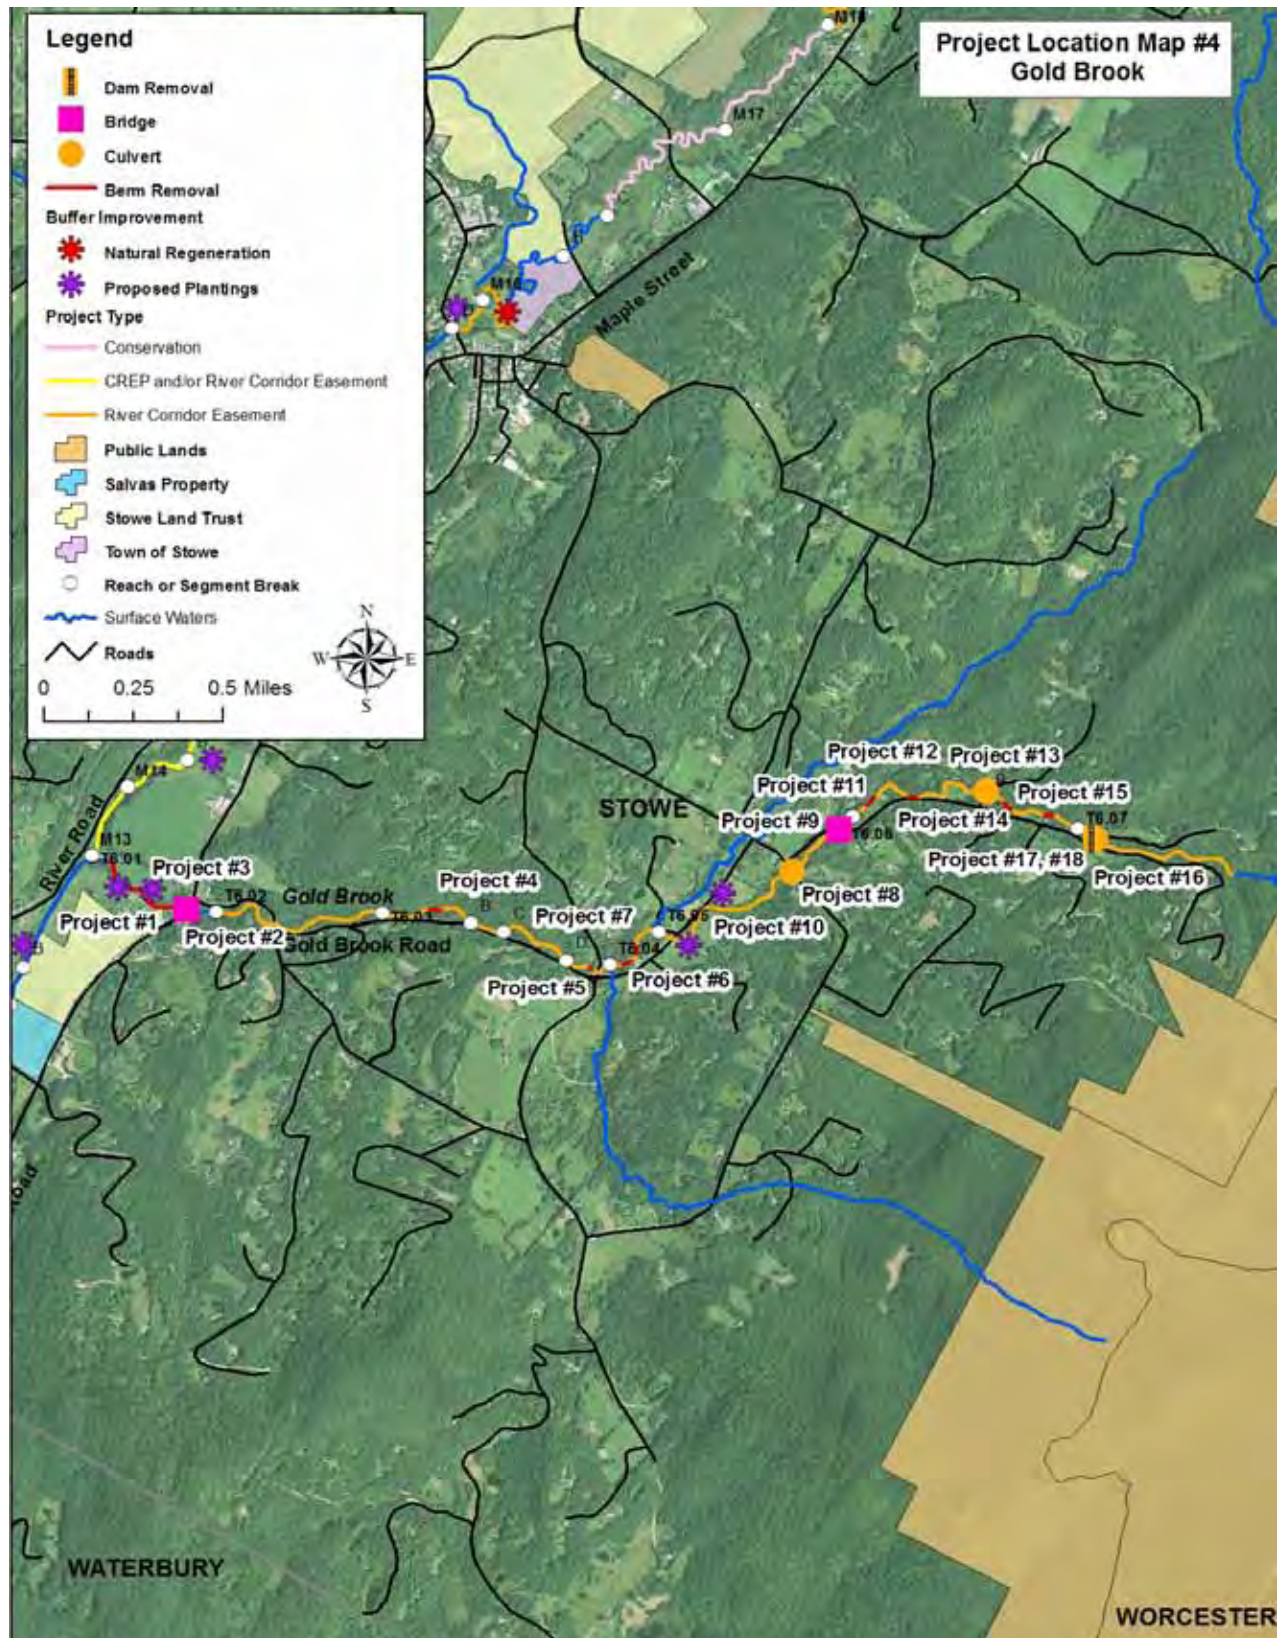
Figure 7.71. Proposed restoration and protection projects for Gold Brook

Gold Brook (see Figure 7.71 and Table 9)

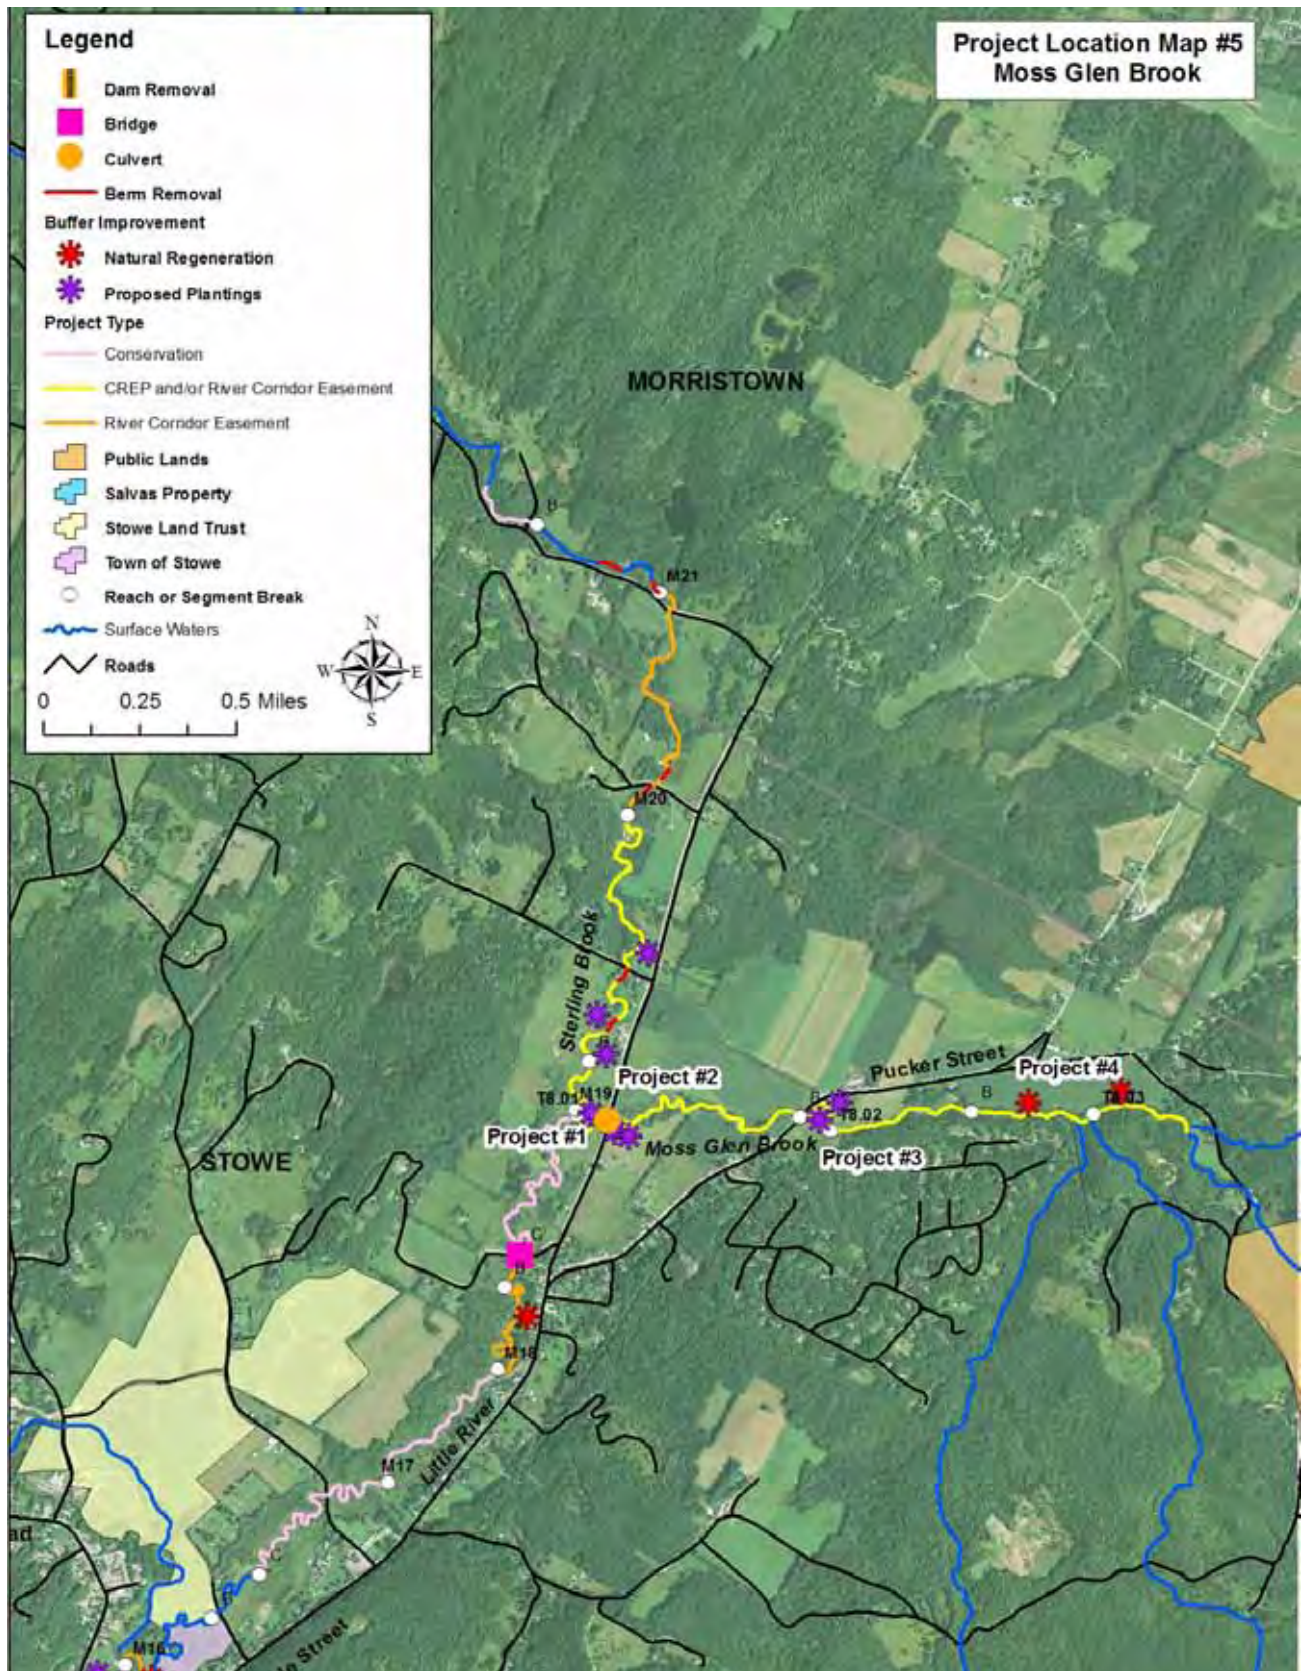
Figure 7.72. Proposed restoration and protection projects for Moss Glen Brook

Moss Glen Brook (see Figure 7.72 and Table 10)

- **Active Restoration** by replacing double undersized culvert at Stagecoach Road that is causing localized geomorphic instability (project #1).
- **Passive Restoration** of river corridor and streamside plantings from confluence with Little River and upstream about 1,200 feet (project #2);
- **Passive Restoration** of river corridor and streamside plantings from Pucker Street to forested area (project #3);
- **Passive Restoration** of river corridor and riparian buffer adjacent to Pucker Street (project #4).
